TOMAHAWK LAKE ASSOCIATION'S STORMWATER AND SHORELAND GIS PROJECT – AN OVERVIEW

Mike Meyer and Jim Kreitlow

August 1, 2020

ASSESSING THE STATE OF TOMAHAWK LAKE'S SHORELANDS - 2020

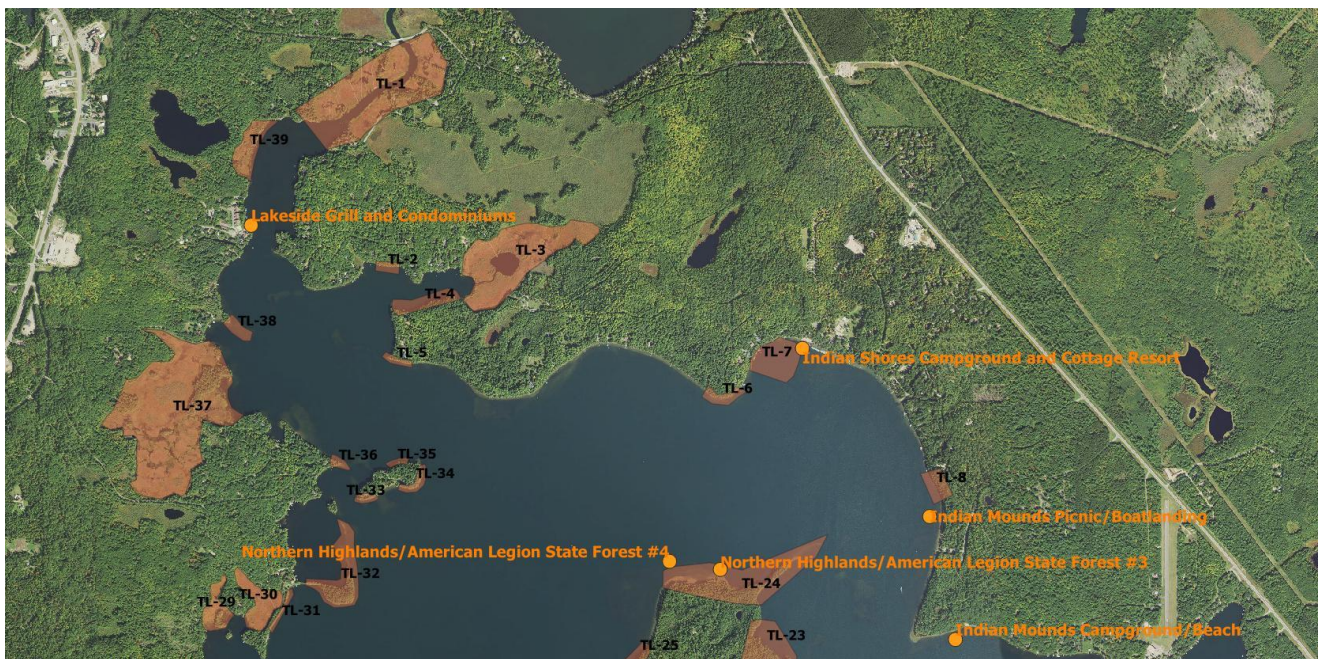
Figure 1. Concentrated Use Sites on Tomahawk Lake - North

A survey was conducted on Friday July 5 to identify properties on Tomahawk Lake with high concentrations of human activity including beach use, boating, commercial operations, recreation, and presence of 15+ people at properties during the surveys. The locations of these public and private properties are shown in comparison to Critical Habitat sites in the maps below. Operators of these properties should be made aware of important natural features in proximity to their operations and the shoreland best management practices that could be undertaken to minimize sediment and nutrient run-off and maximize the protection and restoration of natural habitat on their properties.

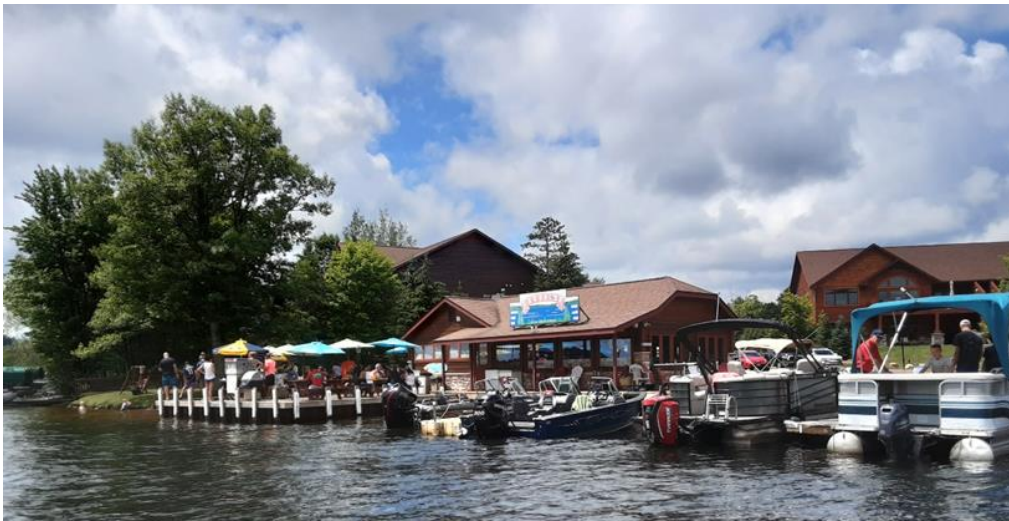
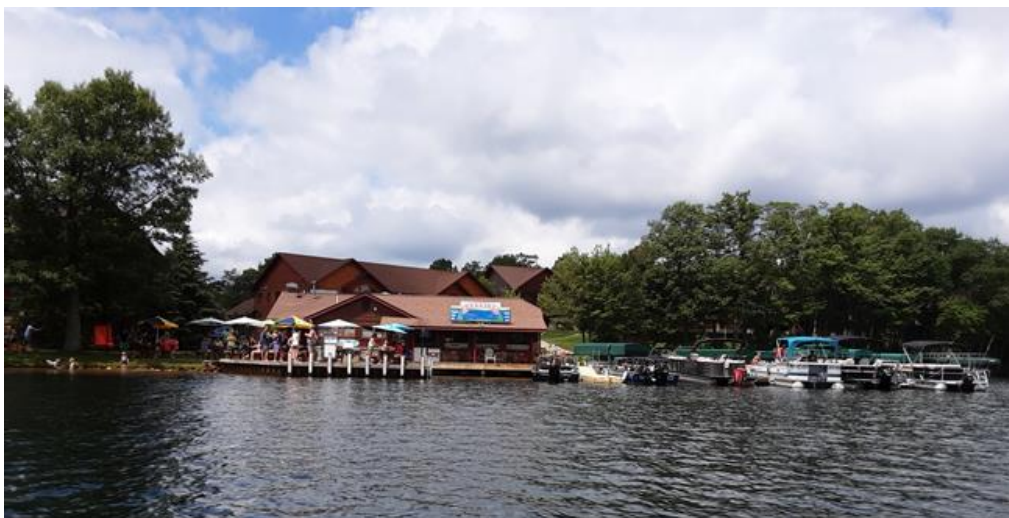
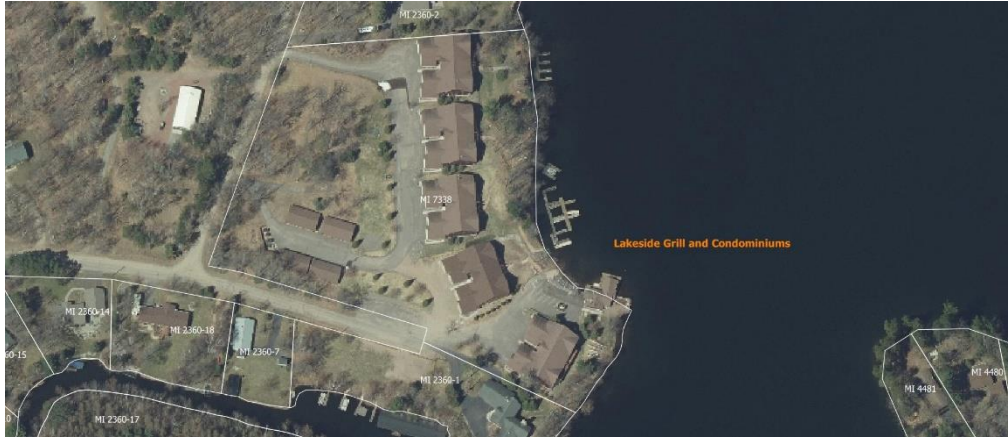
Figure 3. Lakeside Grill Photos and Aerial Map

This popular shoreline restaurant and bar serves customers that arrive by boat and auto. The outside deck is a big draw during warm summer afternoons and evenings. Several condominium units are also on the property. At the time of our survey on July 5th there were 7 boats moored and 65 people at the tables and along the shoreline. Much of the property is covered with pavement and roof tops (impervious surfaces) so practices that minimize run-off to the lake should be employed. Over 50% of the shoreland buffer is impervious surface or manicured lawn but some natural shoreland vegetation remains on the north end of the property and should be maintained. There is little natural habitat on the property shoreline near the restaurant– given its concentrated use it may be difficult to restore or conserve, but an attempt should be encouraged. There were 17 piers and 13 boat lifts present.

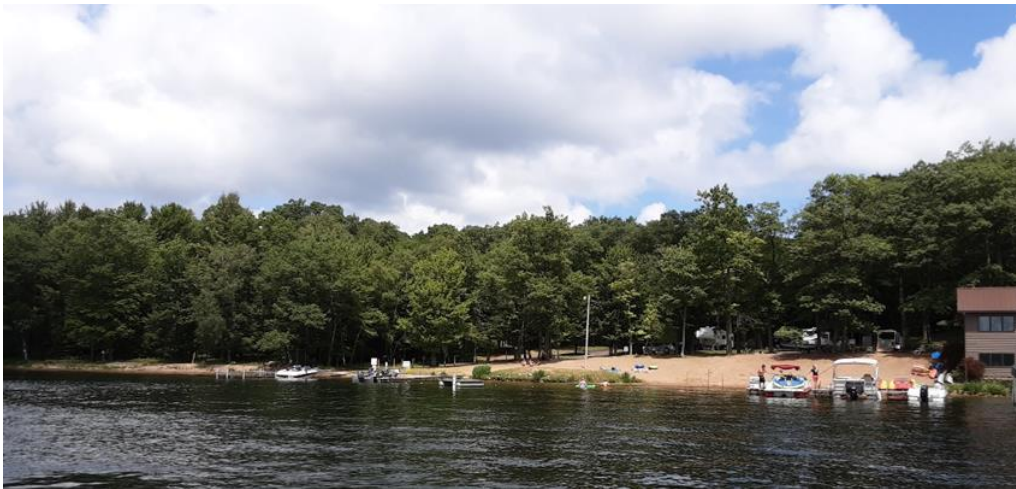
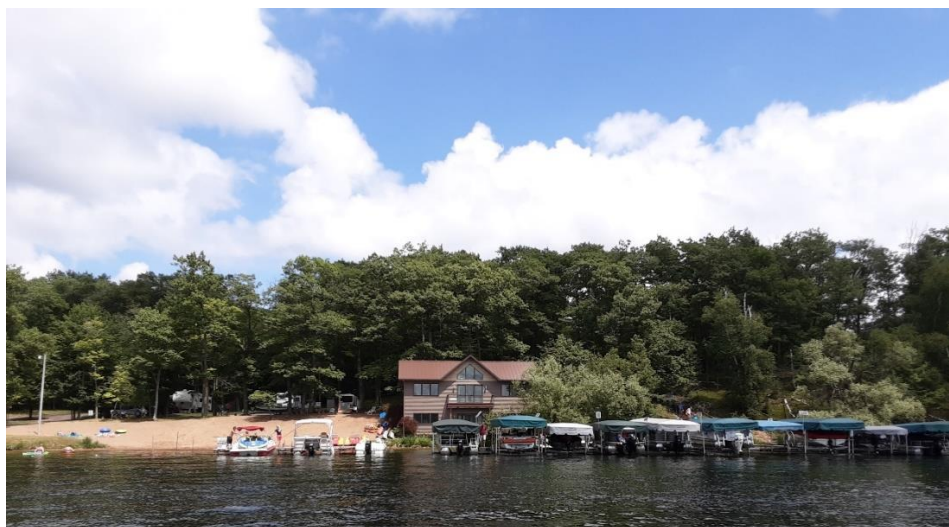
Indian Shores - A Northwoods Campground and Cottage Resort <http://www.indian-shores.com/>

This commercial operation on the north shore of Tomahawk Lake is near critical habitat site TL-7 and our shoreline survey indicated there was evidence of erosion and surface water run-off. Shoreland best management practices should be employed to address these concerns. We also found much of the buffer to be in natural vegetation so a key objective would be to maximize conservation and restoration of natural habitat adjacent to the lake. There are over 30 boat lifts and 5 piers in the Marina so the concentrated boating near the high quality aquatic macrophyte bed (TL-7) is a concern – it would be useful to make boaters aware of this critical habitat which is in close proximity to the marina and boat traffic. See companion Critical Habitat report for more information.

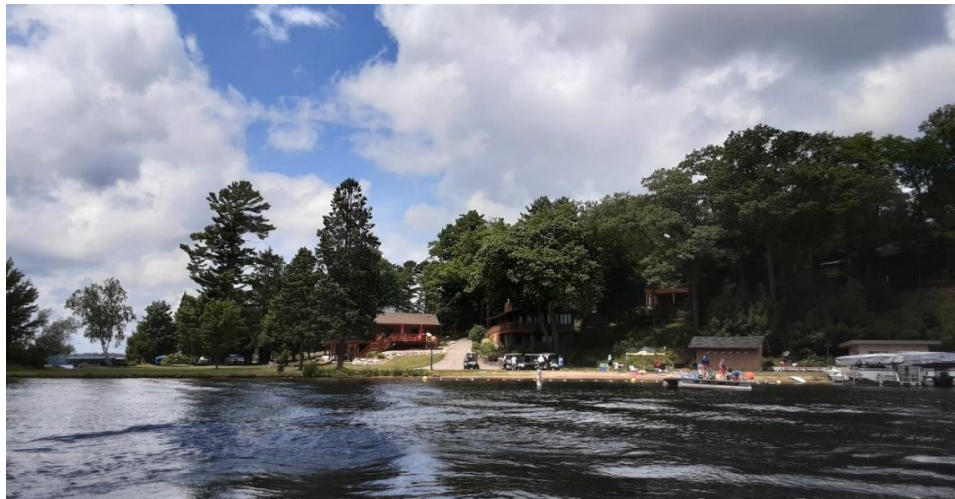
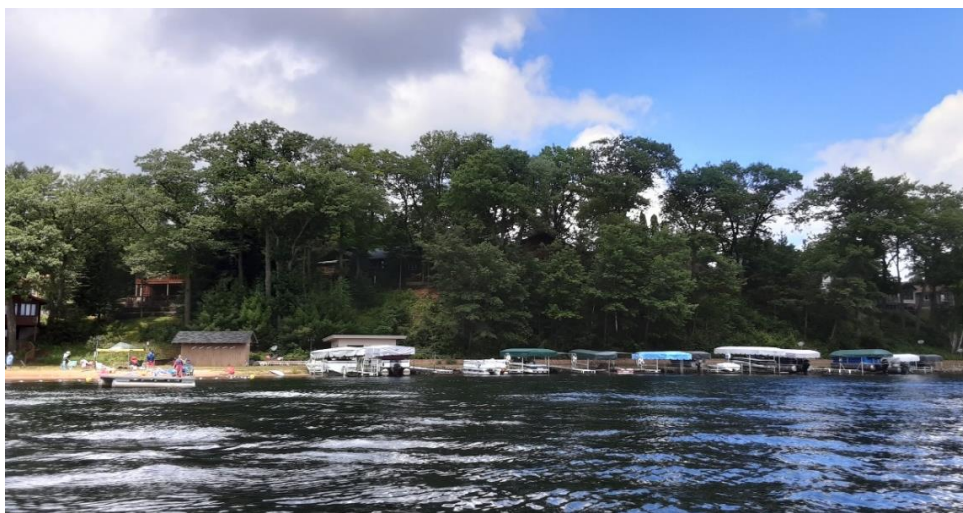
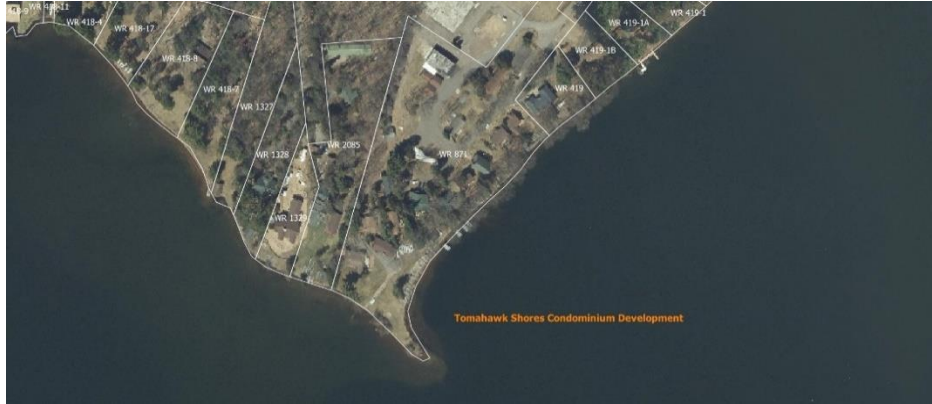
Figure 5. Tomahawk Shores Photos

There is no publicly available information on the *Tomahawk Shores Owners Association* LTD or other information related to the condominium development via the internet. During our shoreline inventory survey of the property on July 19 the buffer was estimated at 35% lawn and impervious surface and there was about 40' of artificial beach. Thirteen piers were counted along with 15 boat lifts. Approximately 25 people were present at the beach and along the shoreline during our July 5 Concentrated Use survey. There was no evident erosion, channeling or gullying from run-off, or bare soil but because of the concentrated use of the site and steep slopes on the north end of the property, care should be taken to divert any potential run-off from reaching the lake or creating erosion.

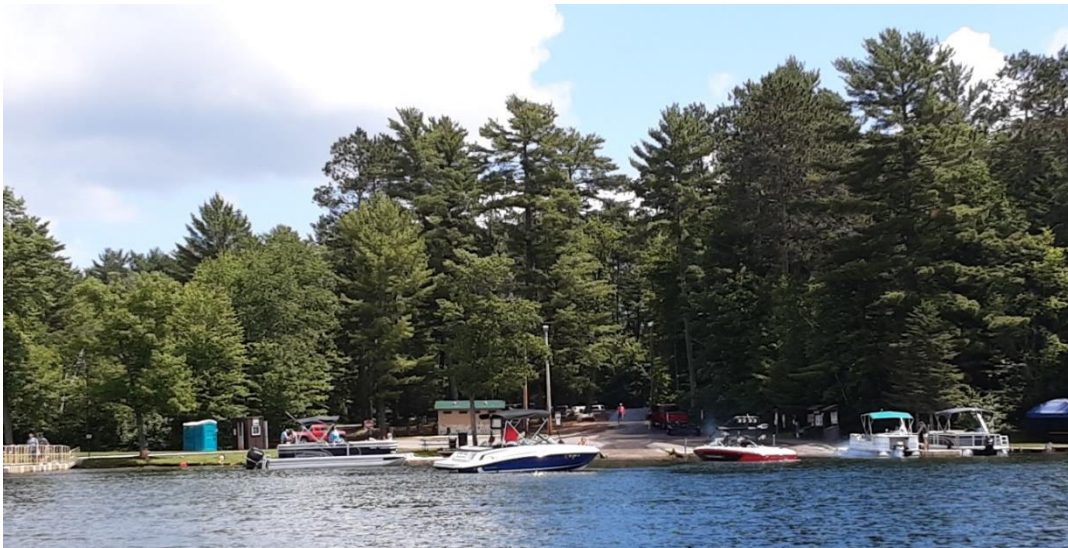
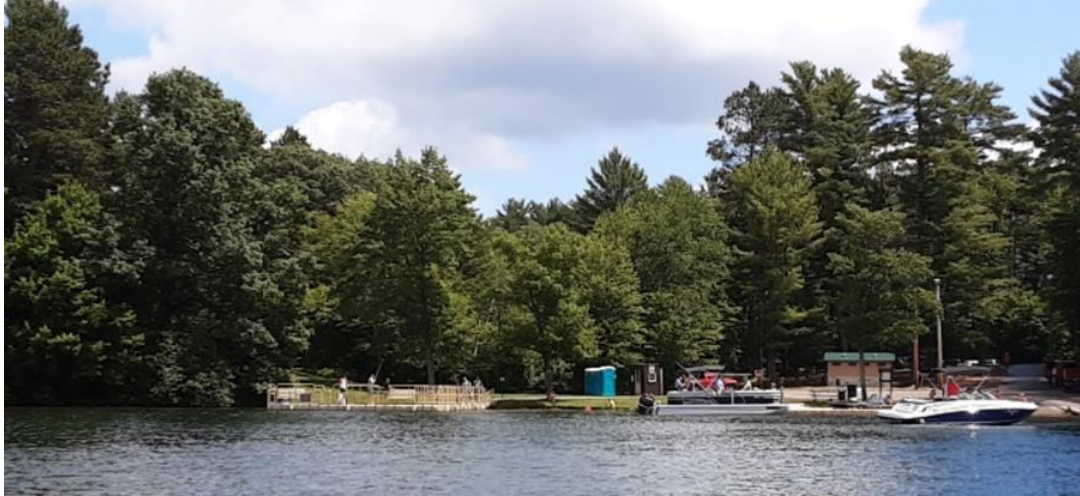
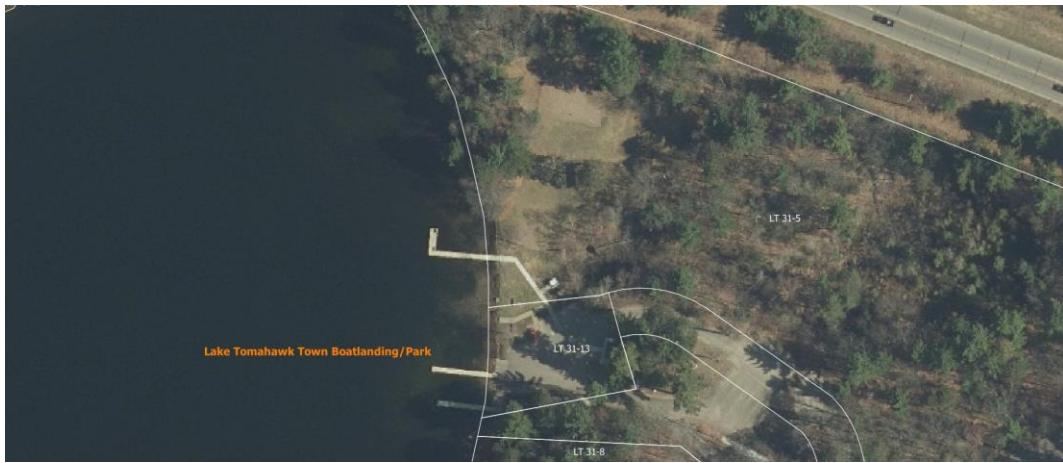
Figure 6. Lake Tomahawk Town Boat Landing Park Photos

“Boat Landing Park is in town on the eastern shore of Tomahawk Lake. The boat landing features three concrete launch ramps, floating docks and tie up piers and new in 2016, a handicapped accessible fishing pier. There is parking for dozens of boat trailers as well as autos. Outhouse style toilets, a wheelchair accessible porta-potty, picnic tables, a volleyball pit and grills make this a fun area to take a swim, have a cookout, or do a little fishing. In the winter months this is an access area for ice fishermen and snowmobiles. The hill is used for sledding and snowboarding as well.”

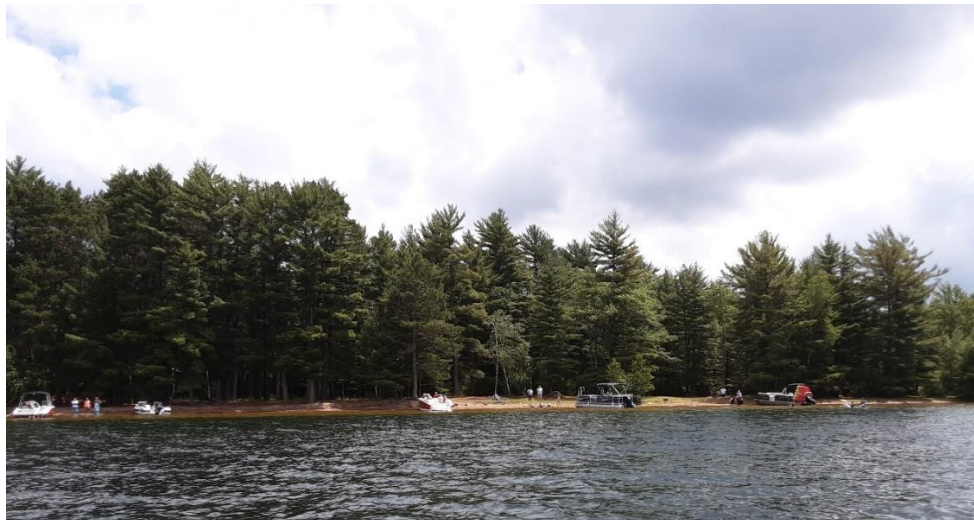
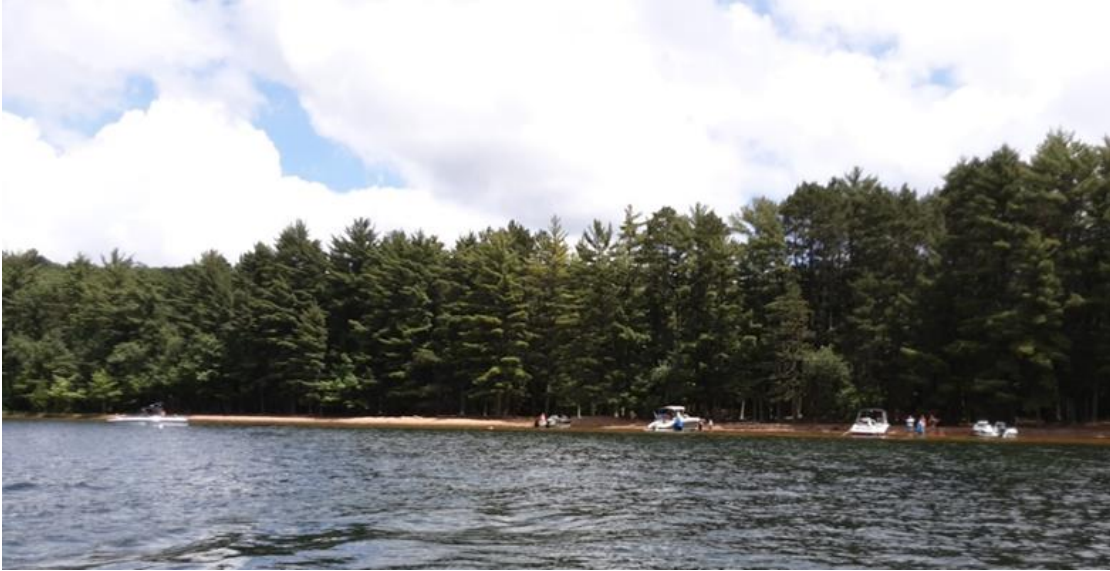
Figure 8. Indian Mounds Picnic Area and Boat Landing Photos

The Wisconsin DNR operates the Indian Mounds Campground and Picnic Area on the northcentral portion of the lake shoreline. Boats anchor and people picnic and swim at the picnic area north of the boat landing which until recently was also managed as a swimming beach. At the time of the July 5th survey there were 5 boats anchored and 15-20 people using the shore area. At times over the summer there were over 20 boats anchored at this location with 60+ people using the site. The shoreland buffer is primarily in natural vegetation and there was no obvious run-off or erosion concerns (as there is little slope in the beach/boat landing area) though the site should be monitored as concentrated use of the areas will continue and there is a walleye spawning area (TL-8) just to the north of the picnic area where the shoreline slope is steep. The boat landing is a popular boat launching area when lake levels are normal to high but launching is difficult for larger boats during low water periods. There is much prop scouring of the bottom in this area. Several dozen vehicles and trailers were observed during busy summer days in the boat landing parking lot. See companion Critical Habitat report for more information.

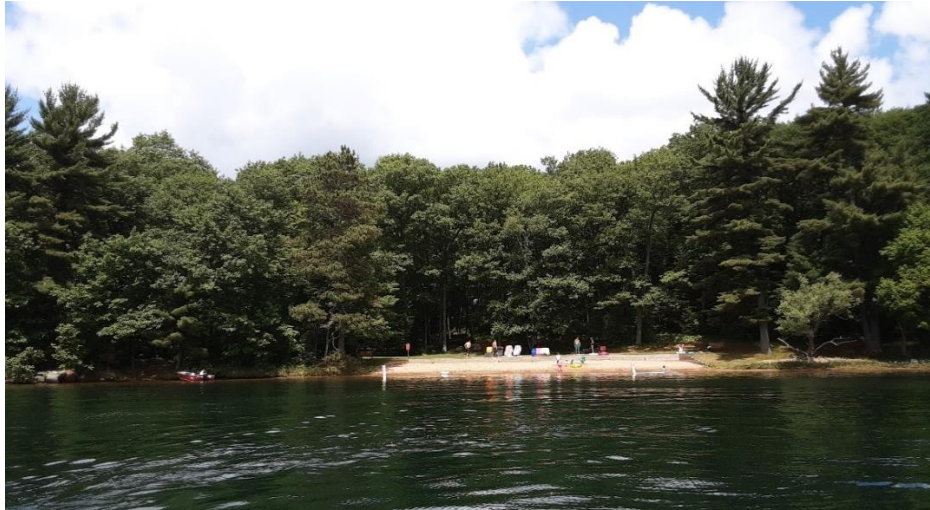
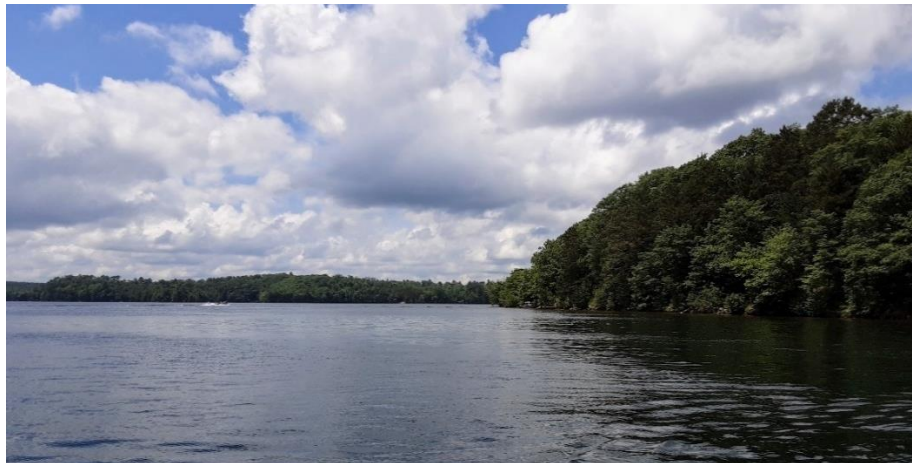
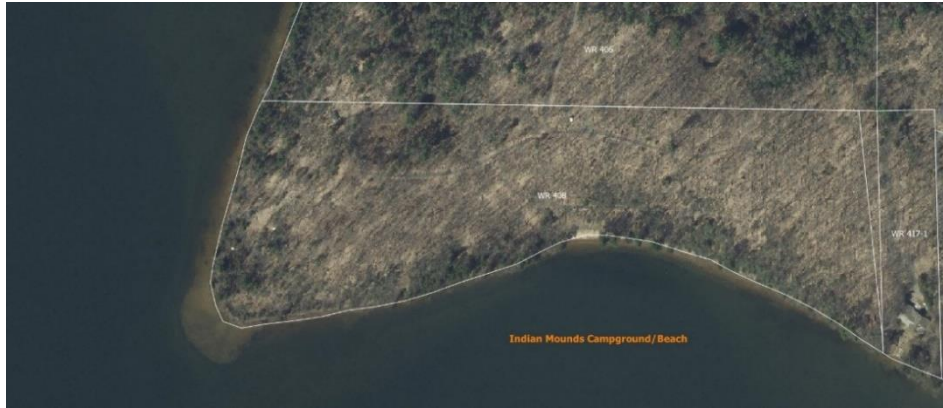
Figure 9. Indian Mounds Campground/Beach Photos

There are 39 campsites at this WDNR property and a beach area. The campground is open for camping when snow-free and generally at capacity during July and August. There are steep slopes along a portion of the northern shore with extensive erosion, gullying/channeling, and surface water run-off due to foot traffic associated with the campsites. Boats are moored along the shoreline as well, without improved docking sites.

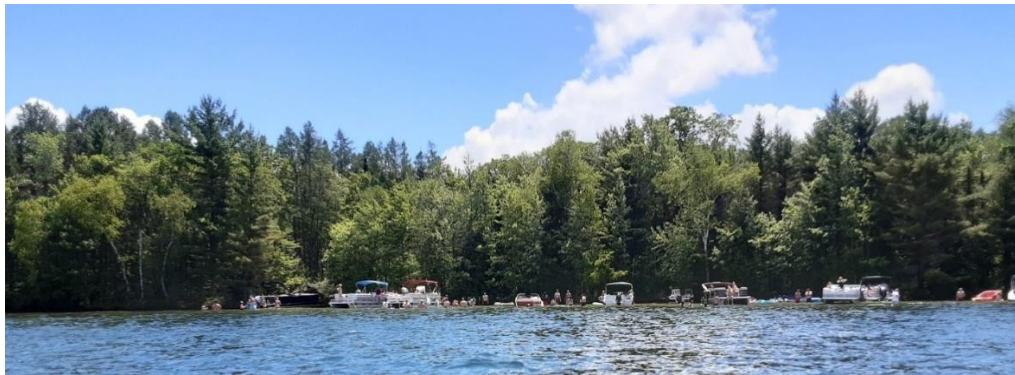
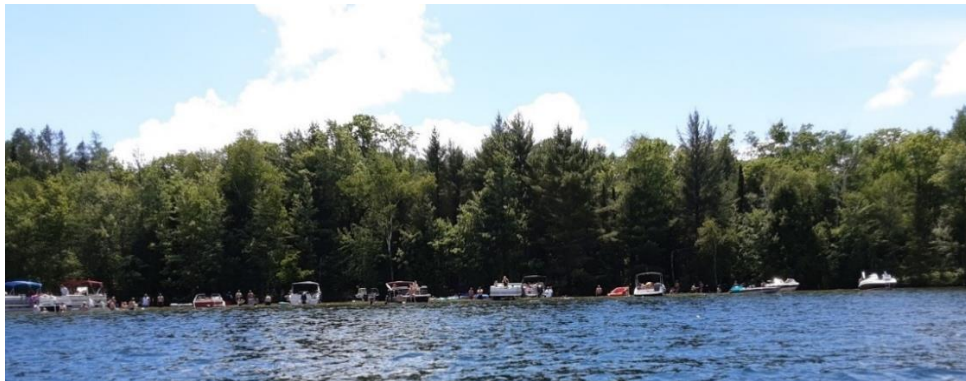
Figure 10. Northern Highland/American Legion State Forest #1 Photos

There are 4 locations on State of Wisconsin shoreland parcels where we noted large numbers of boats and jet skis anchored or pulled ashore along long stretches of shoreline. These areas are relatively shallow and sandy, offering ideal swimming and water sport (water skiing, waterboarding, jet skiing) staging areas. When we conducted the survey between 1PM and 2PM on July 5 there were 15 boats moored and 62 people enjoying site #1. Despite this high level of use, only 40' of bank erosion was noted – the upland area is level. This area is adjacent to and within Critical Habitat site TL-17 (See companion report on Critical Habitat).

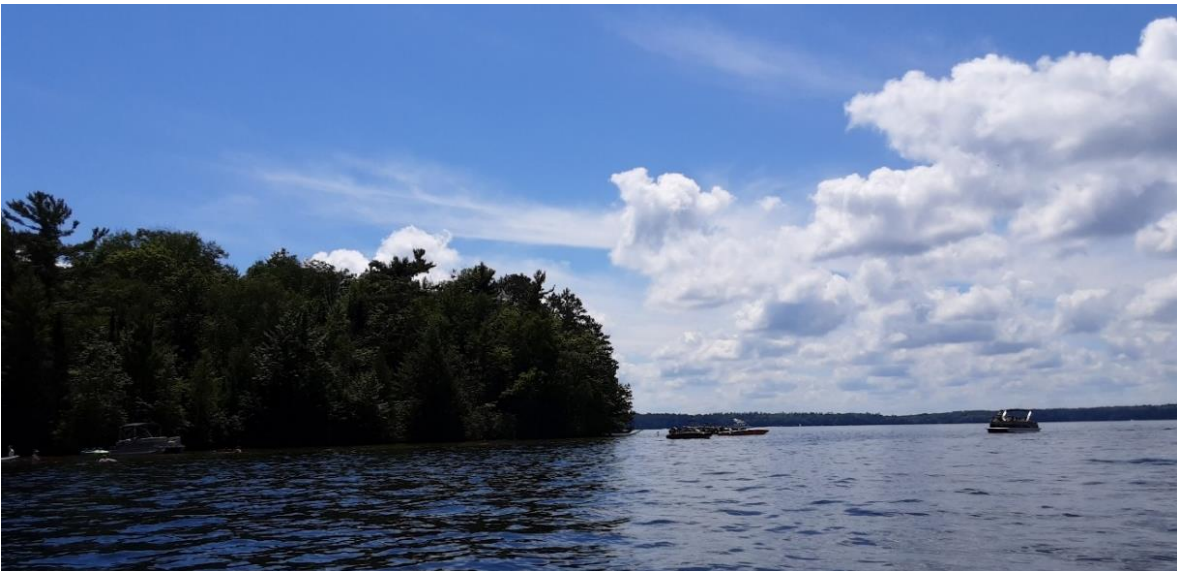
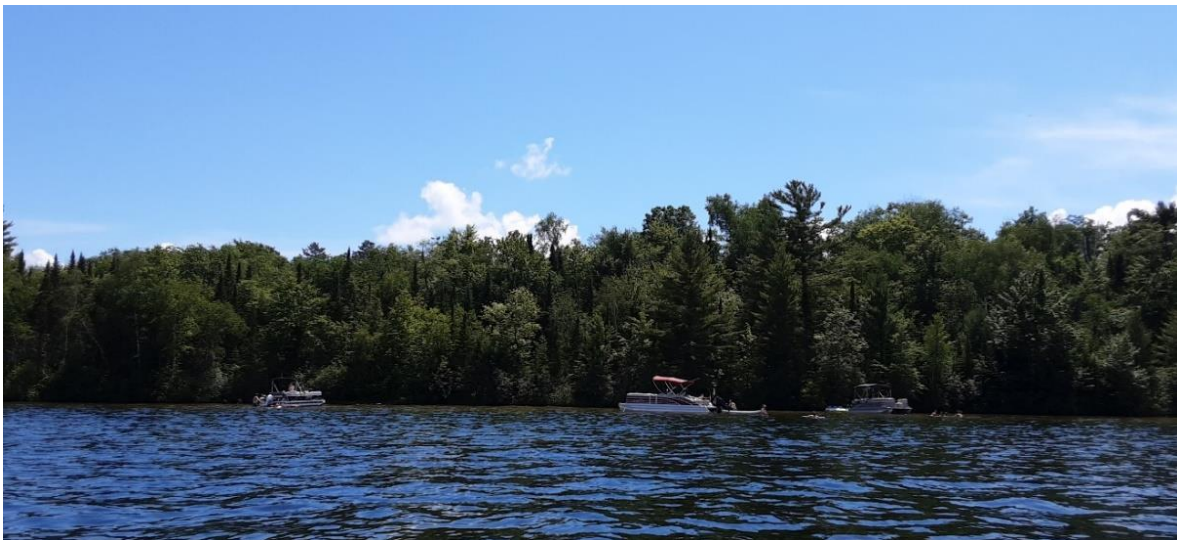
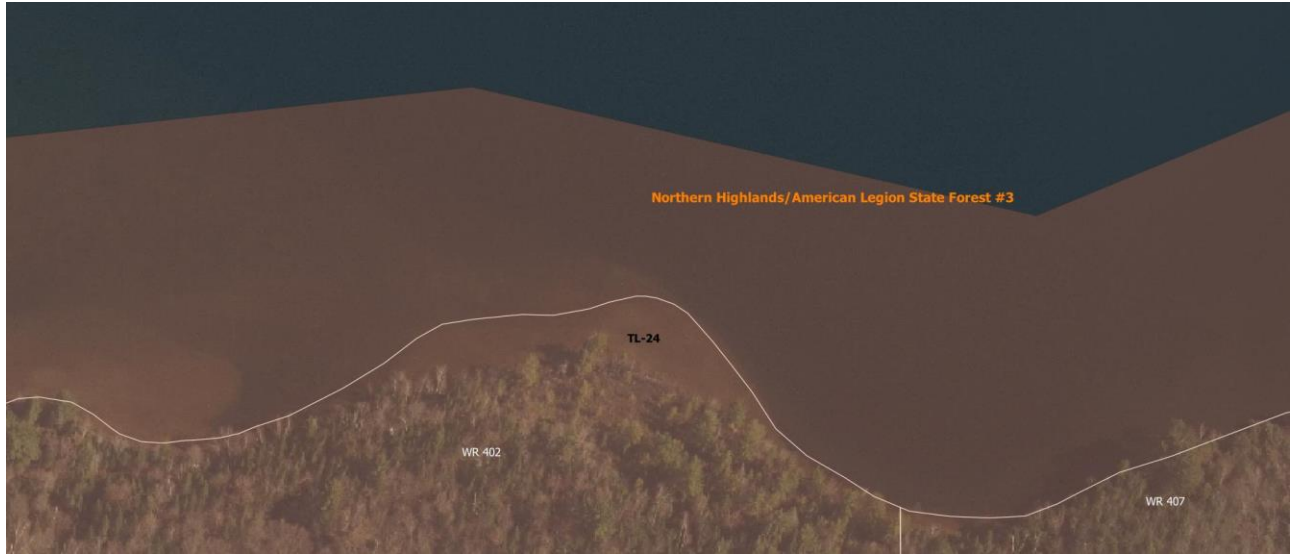
Figure 12. Northern Highlands/American Legion State Forest #3 Photos

Two concentrated use areas were located on the north shoreline of Windy Point. At the time of the July 5th survey there were 25 boats and 3 jet skis at anchor and between 80-100 people present on the shoreline, in anchored boats, or in the water. Several ski boats and jet skis were actively using the area. Extensive gullying and channeling of the adjacent uplands and buffer was associated with the activity as well as bank erosion. These sites have the most severe erosion problems on Tomahawk Lake and are within Critical Habitat site TL-24 (See companion report on Critical Habitat for more information).

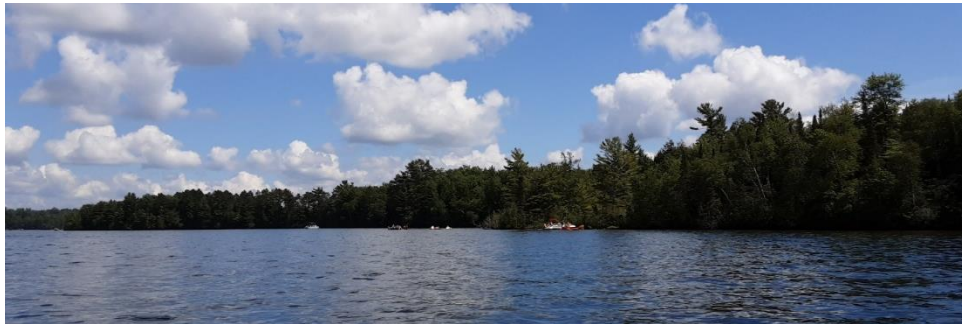
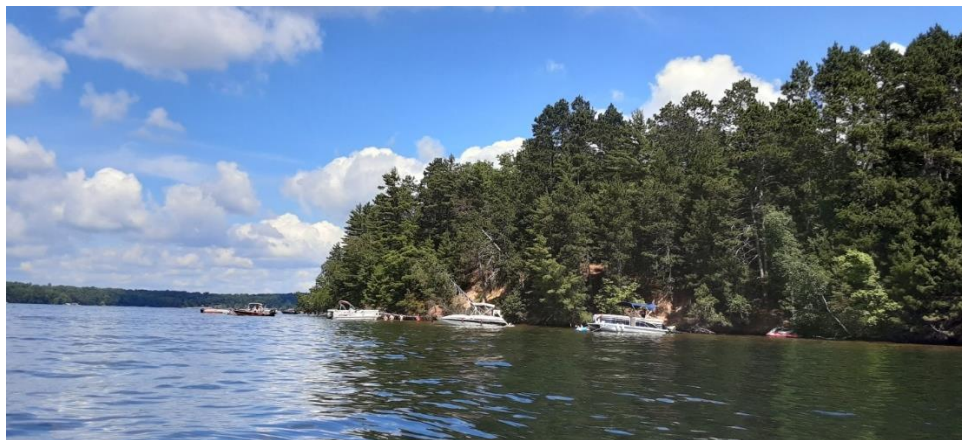
Figure 13. Northern Highlands/American Legion State Forest #4 Photos

This location, often referred to the “otter slide”, had the most severe erosion and run-off problems observed on Tomahawk Lake. Human use of the adjacent steep sandy upland has resulted in over 200’ of gullying and channeling of run-off with >250’ of bank erosion present. Because of the high concentration of use and steep slopes, management of the site could include fencing and signage and perhaps seasonal porta-potty facilities to keep people off the steep upland sites. Again, this location is within Critical Habitat site TL-24 – see Critical Habitat Report for more information.

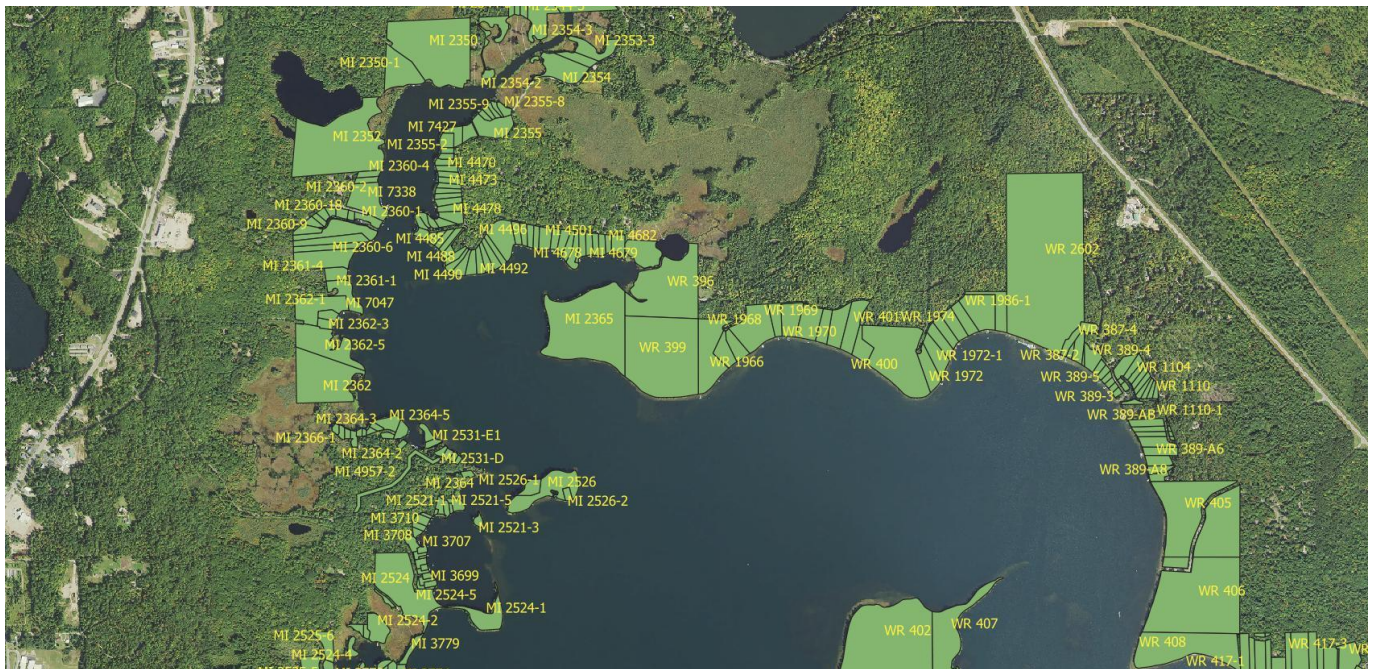
Figure 14. Tomahawk Lake Shoreland Parcels - North

We conducted boat surveys July – August 2019 of the Tomahawk Lake shoreline and assessed the upland and shoreland buffer condition and identified erosion and run-off issues on 414 tax parcels adjacent to Tomahawk Lake, Oneida County in 2019, using the draft WDNR Lake Shoreland & Shallows Habitat Monitoring Field Protocol (Hein et al. 2016). We identified 38 properties with potential upland and/or buffer gullying and channeling due to surface water run-off, 83 parcels with potential bank erosion, and 144 with buffers that were greater than 40% in manicured lawn and/or impervious (hard, non-porous) surfaces. **As this was a one-time shoreland evaluation done offshore by boat, an actual onsite visit is needed to confirm the survey results (see Recommendations to Property Owners in Section 4).**

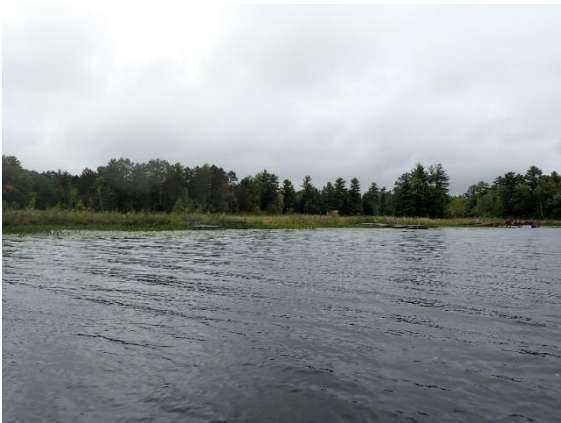
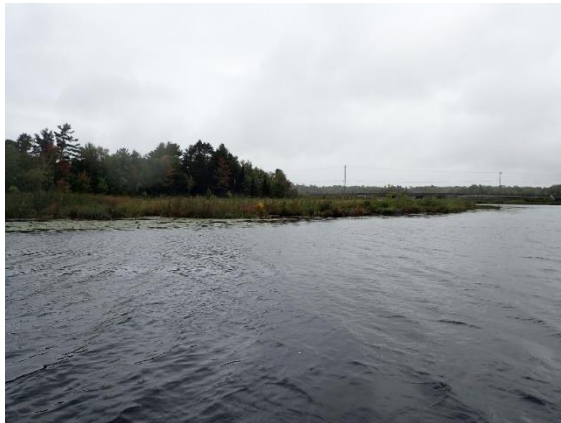
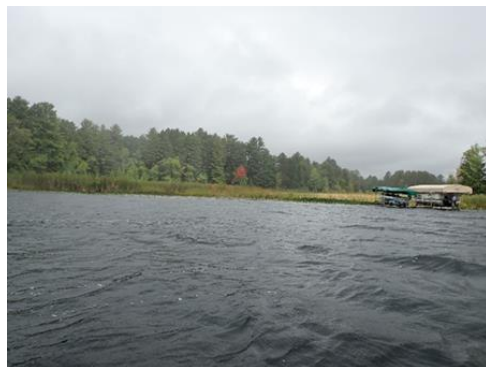
TL-2 Kemp Bay Gravel Bar (northwest of Kemp Station boathouse)

This is a rock/gravel bar. It was selected for its fishery value (photos).

1. Maintain current protection.
2. No alteration of littoral zone.
3. Add fallen trees or coarse wood along the shoreline.
4. Restore or increase shrub/herbaceous plant cover.

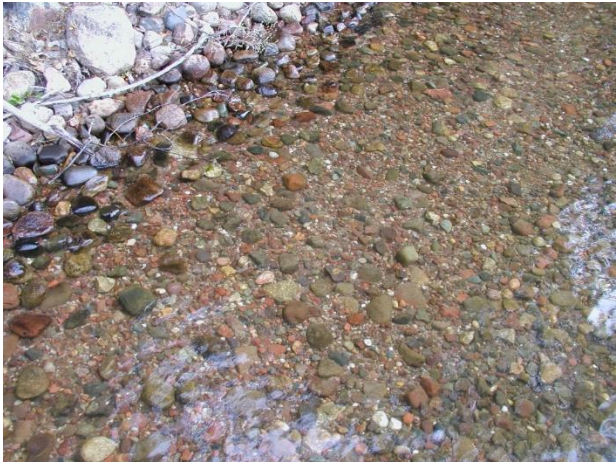
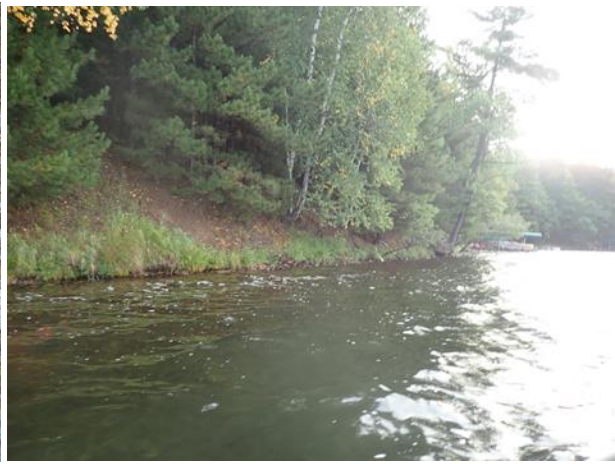
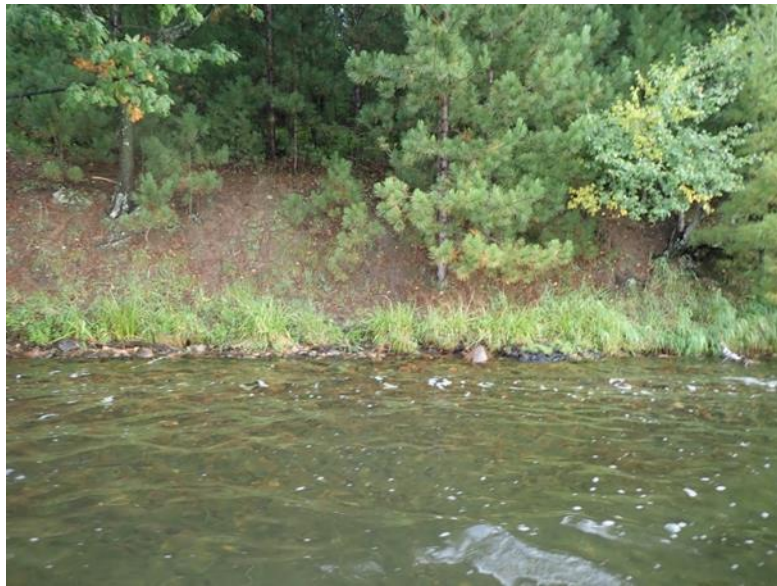
TL-3 Kemp Bay Wetland Complex (east end of bay)

This is a large diverse wetland. It was selected for its fish and wildlife values, diverse aquatic vegetation and natural scenic beauty. There is minimal human disturbance (photos). An open water area (e.g. the Paddle Pond) is found in the center of the wetland.

1. Maintain current protection.
2. No alteration of littoral zone.
3. Maintain snag and cavity trees for cavity nesting species.
4. Maintain fallen trees along the shoreline.

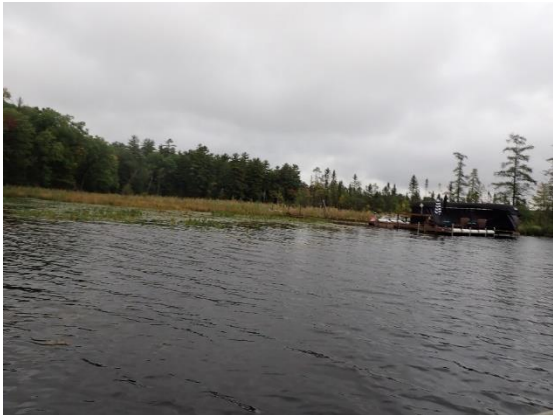
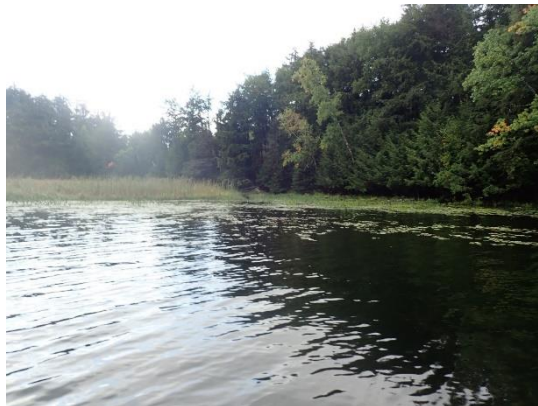
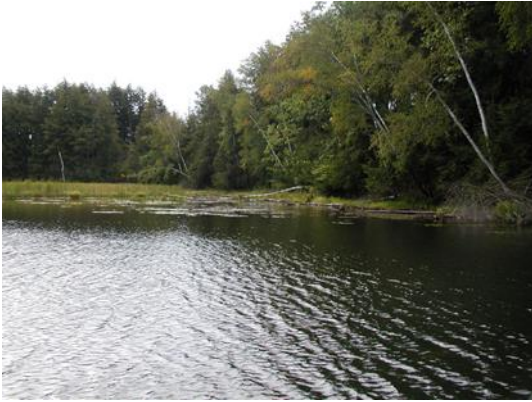
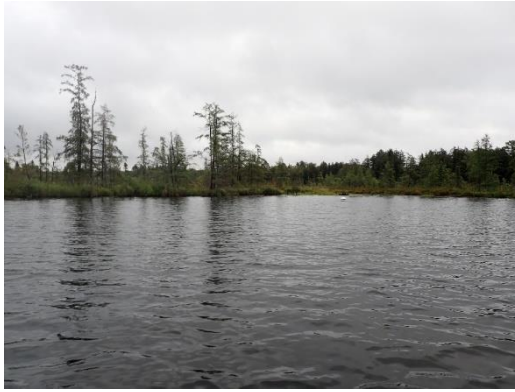
TL-4 Kemp Bay Coarse Wood (south shoreline)

This site contains abundant coarse woody cover. It was selected for its fish and wildlife values, diverse submerged aquatic vegetation and natural scenic beauty. There is minimal human disturbance. (photos)

1. Maintain current protection (slow no wake).
2. No alteration of littoral zone.
3. Maintain snag and cavity trees for cavity nesting species.
4. Maintain fallen trees along the shoreline.
5. Do not remove woody cover.

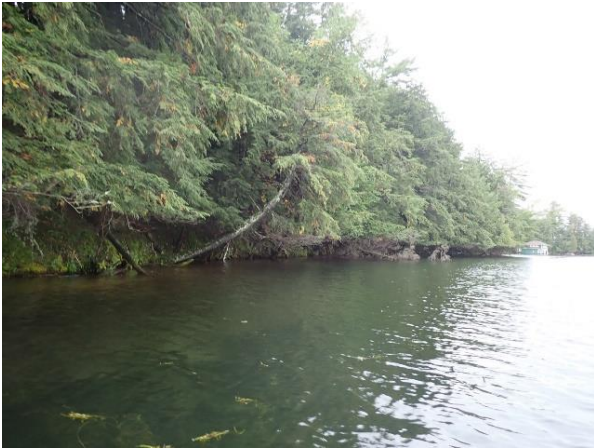
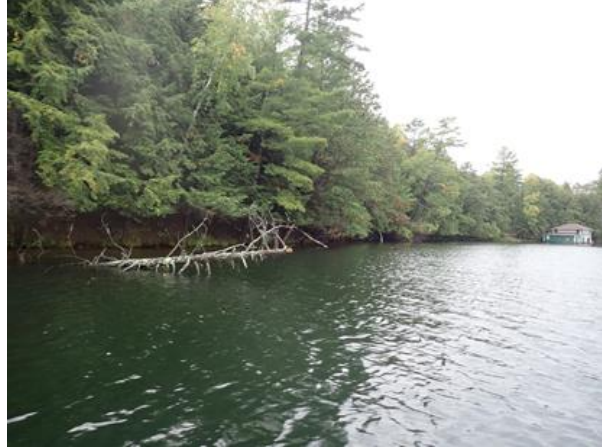
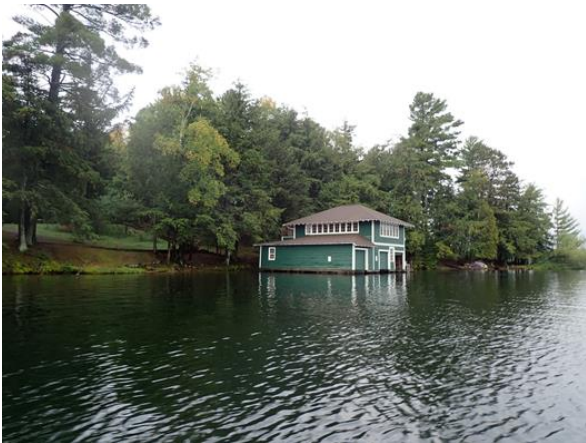
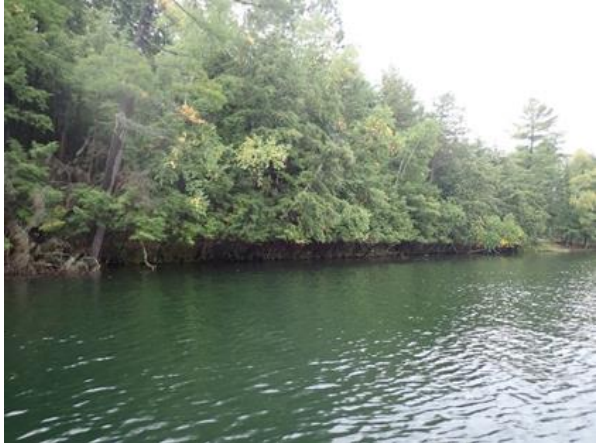
TL-5 Kemp Point Rock/Gravel Bar (southern point)

This is a rock/gravel bar. It was selected for its fishery value (photos).

The site includes near-shore terrestrial, shoreline and littoral zone habitats. The riparian type (%) is 100% wooded. The buffer zone (from water's edge to 35 feet back) is dominated by trees with an abundant herbaceous/shrub layer. Coarse woody cover is present.

1. Maintain current protection of riparian zone.
2. No alteration of littoral zone.
3. Add fallen trees or coarse wood along the shoreline.

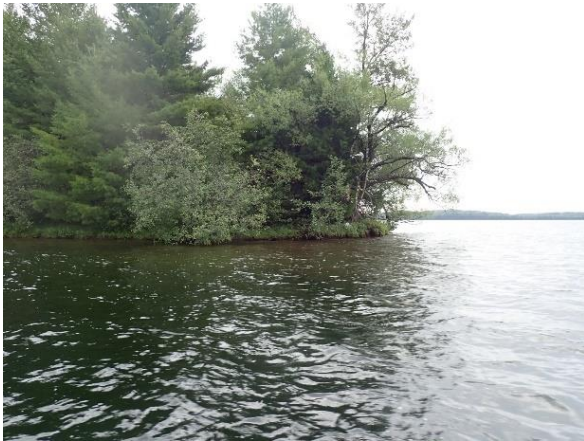
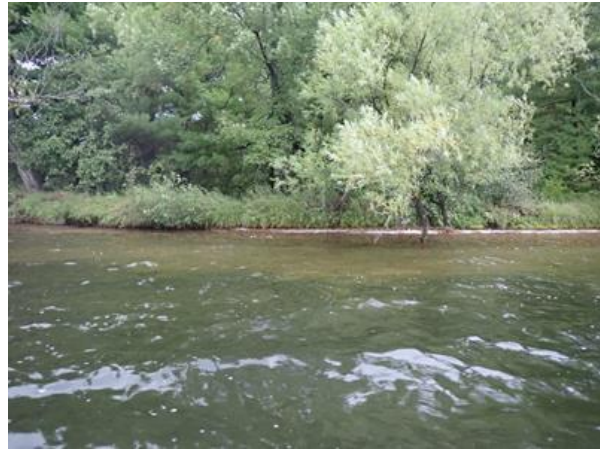
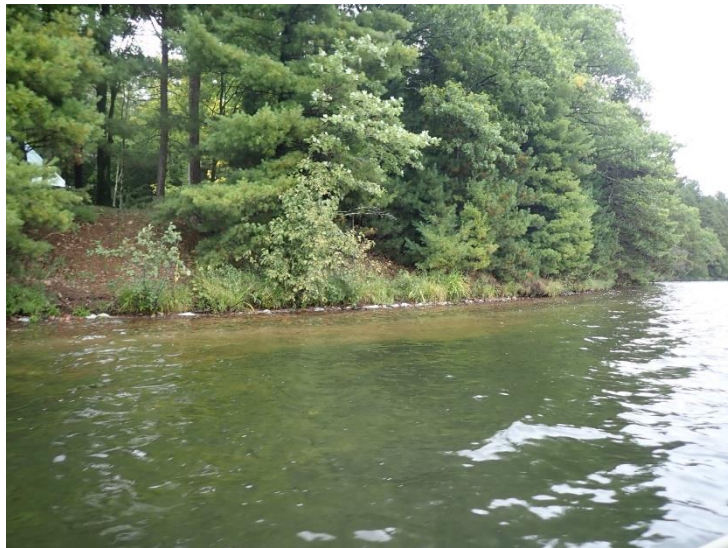
TL-6 Rock/Gravel Bar (south of South Cross Cut Trail Road)

This is a rock/gravel bar. It was selected for its fishery value (photos)

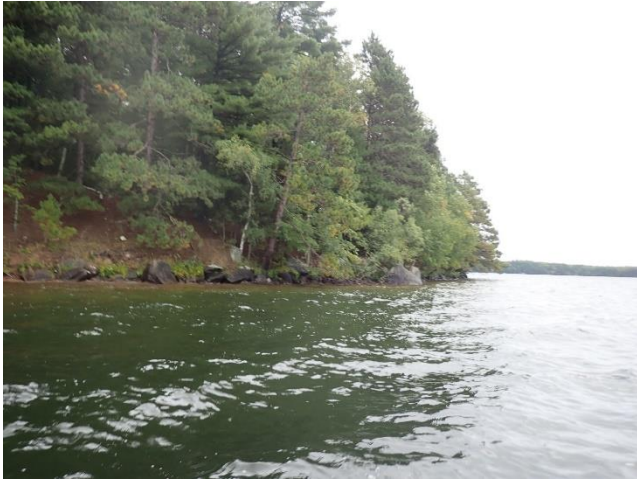
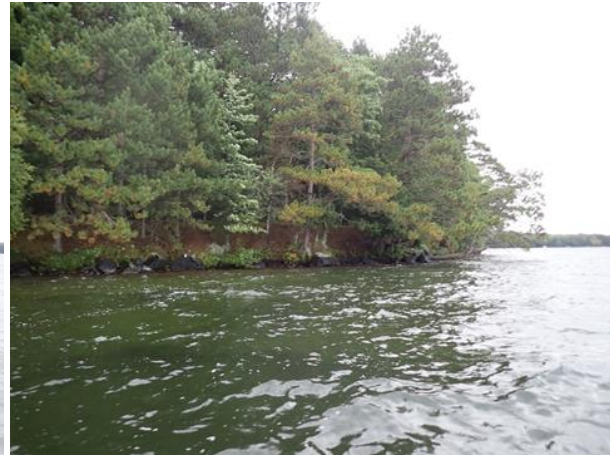
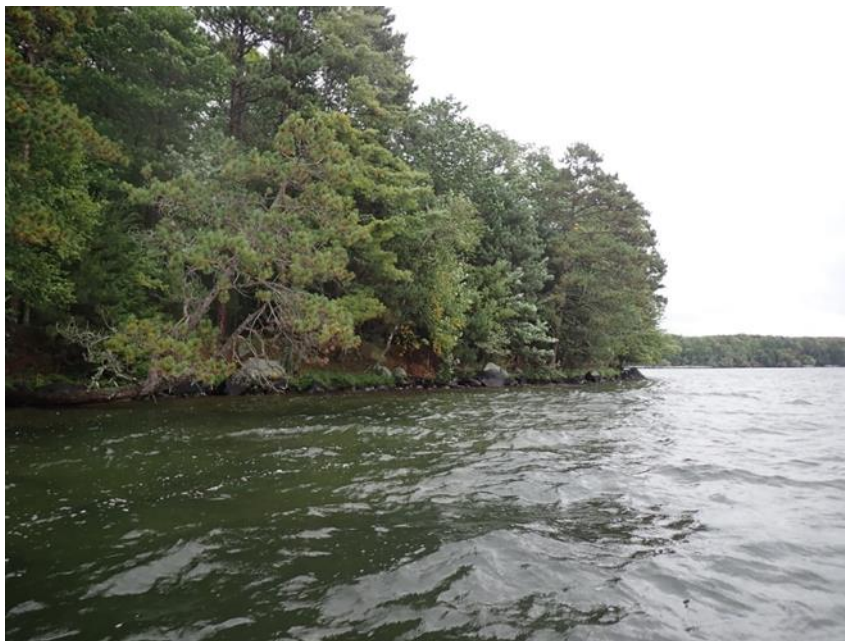
TL-7 Diverse Plant Bed (off Camp Strongheart Road)

This is a diverse aquatic plant bed, rare on this side of the lake. It was selected primarily for its fishery value (photos).

The site includes nearshore terrestrial, shoreline and littoral zone habitats. The riparian type (%) is 60% wooded and 40% developed. The buffer zone (from water's edge to 35 feet back) is dominated by herbaceous/scrubs with lawn present. Diverse submergent aquatic vegetation is abundant.

1. Maintain current protection.
2. No alteration of littoral zone.
