TOMAHAWK LAKE ASSOCIATION'S STORMWATER AND SHORELAND GIS PROJECT – AN OVERVIEW

Mike Meyer and Jim Kreitlow

August 1, 2020

ASSESSING THE STATE OF TOMAHAWK LAKE'S SHORELANDS - 2020

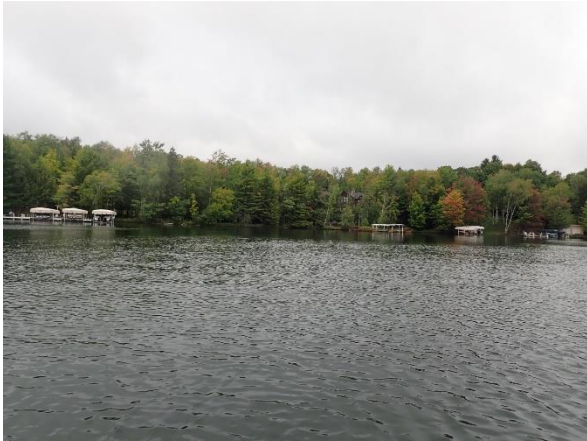
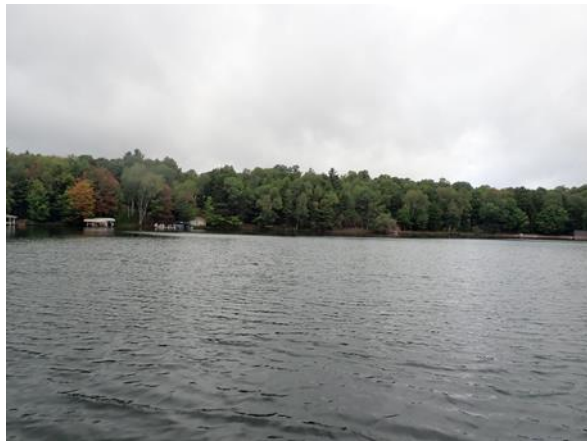
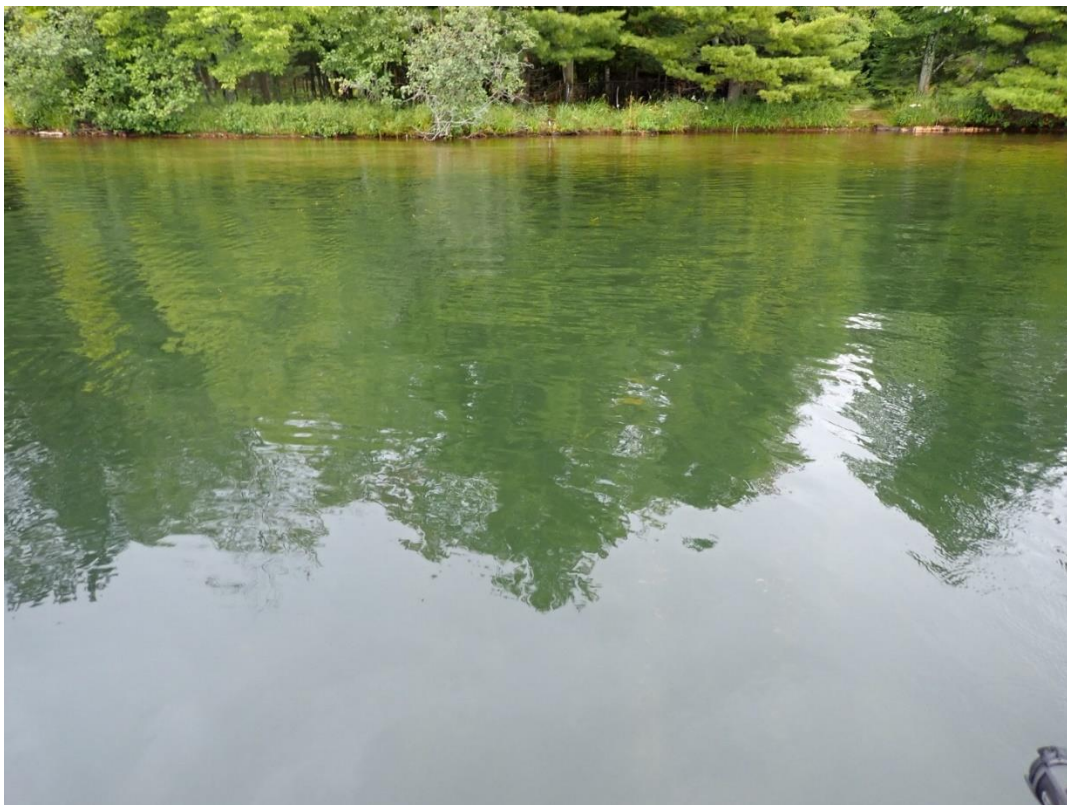
TL-8 Rock/Gravel Bar (off Pine Aire Lane)

This is a rock/gravel bar along an undeveloped shoreline. It was selected for its fish and wildlife value (photos).

The site includes near-shore terrestrial, shoreline and littoral zone habitats. The riparian type (%) is 100% wooded. The buffer zone (from water's edge to 35 feet back) is dominated by trees with an abundant herbaceous/shrub layer.

1. Maintain current protection of riparian zone.
2. No alteration of littoral zone.
3. Add fallen trees or coarse wood along the shoreline.

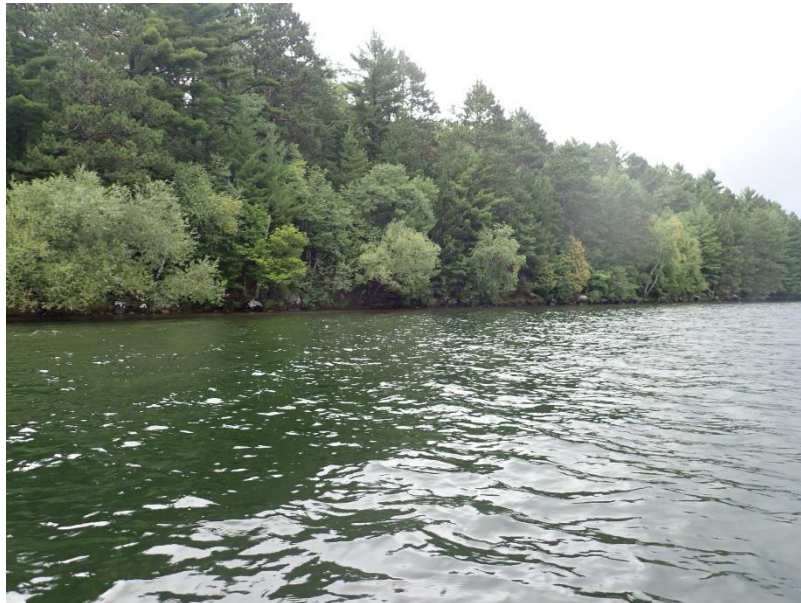
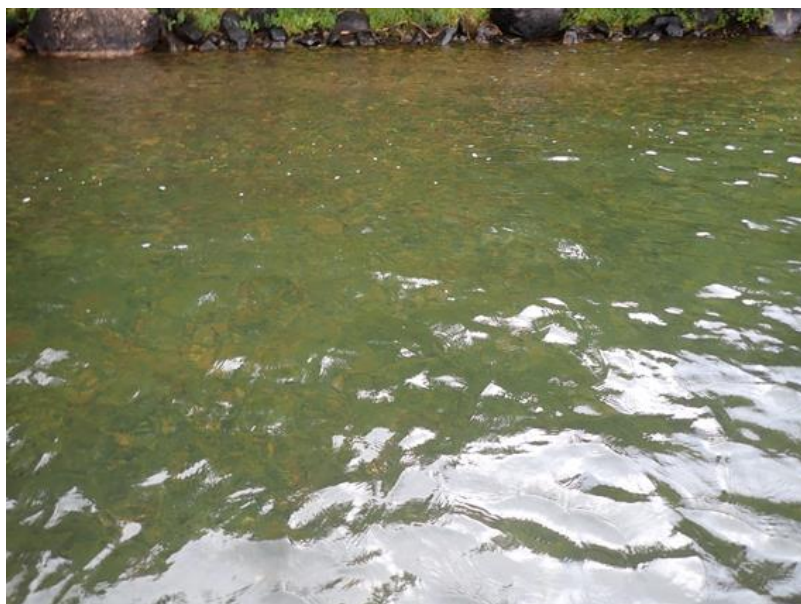
TL-9 Owl Road Wetland Complex (far eastern end of lake)

This is a diverse wetland. It was selected for its fish and wildlife values and diverse aquatic vegetation (photos).

The site includes nearshore terrestrial, shoreline and littoral zone habitats. The riparian type (%) is 50% wetland, 40% wooded and 10% developed. The buffer zone (from water's edge to 35 feet back) is dominated by herbaceous/scrubs with trees common and a small amount of lawn present. Coarse woody cover is abundant.

1. Maintain current protection.
2. No alteration of littoral zone.
3. Maintain snag and cavity trees for cavity nesting species.
4. Maintain fallen trees along the shoreline.

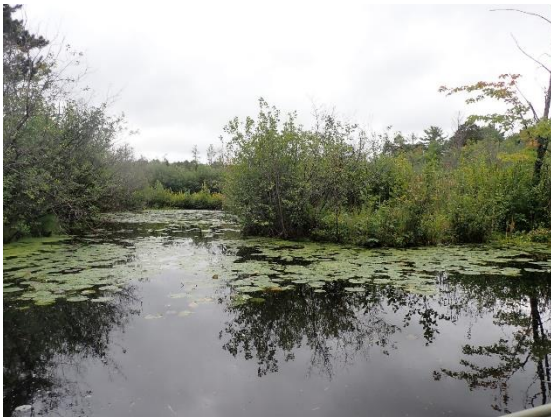
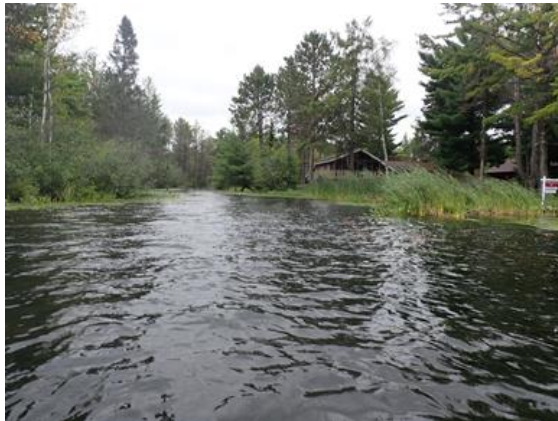
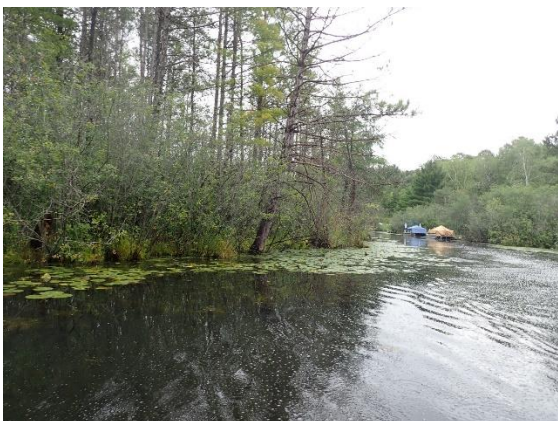
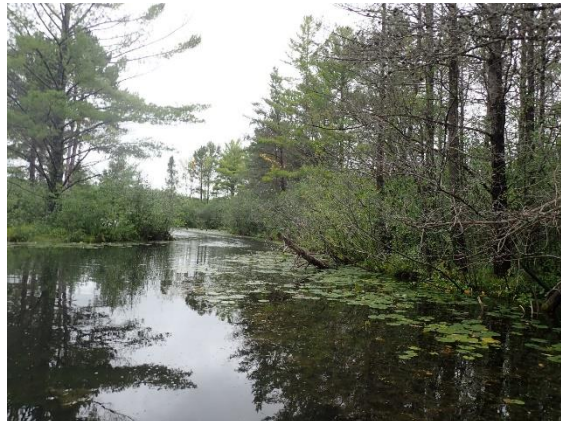
TL-10 Rock/Gravel Bar (north of Blue Jay Road)

This is a rock/gravel bar along an undeveloped shoreline. It was selected for its fish, wildlife value and scenic beauty (photos).

The site includes near-shore terrestrial, shoreline and littoral zone habitats. The riparian type (%) is 100% wooded. The buffer zone (from water's edge to 35 feet back) is dominated by trees with an abundant herbaceous/shrub layer. Coarse wood is present.

1. Maintain current protection of riparian zone.
2. No alteration of littoral zone.
3. Add fallen trees or coarse wood along the shoreline.

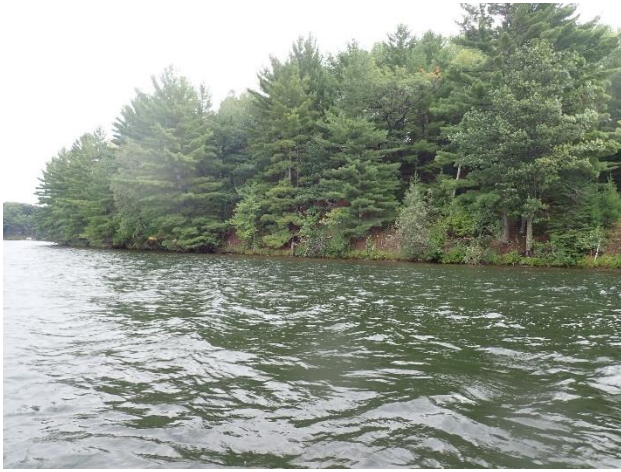
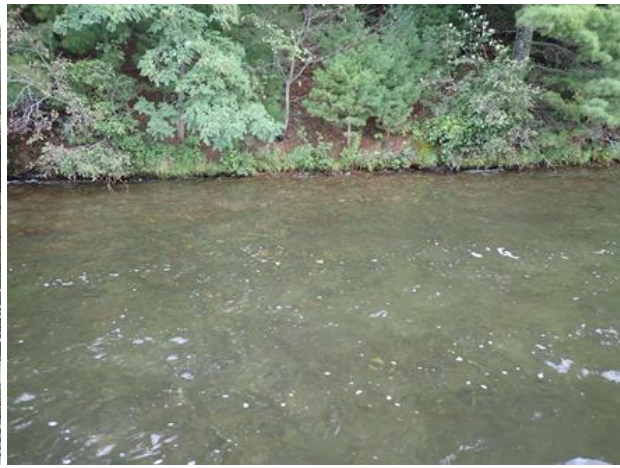
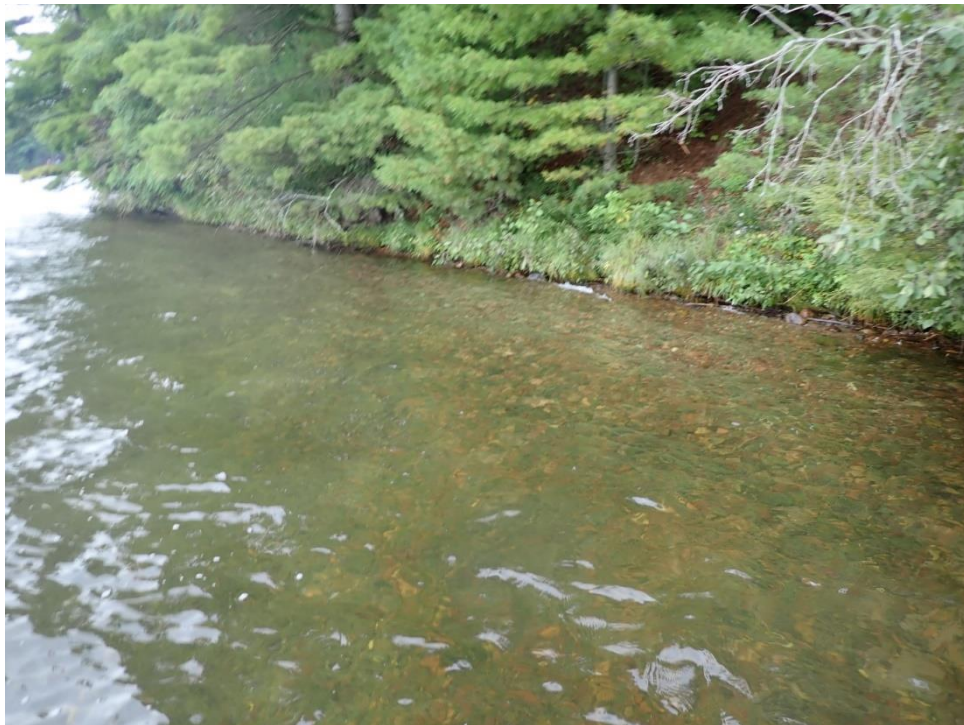
TL-11 Rock/Gravel Point (west of Blue Jay Road)

This is a rock/gravel bar along an undeveloped point. It was selected for its fish, wildlife value and natural scenic beauty (photos).

The site includes near-shore terrestrial, shoreline and littoral zone habitats. The riparian type (%) is 100% wooded. The buffer zone (from water's edge to 35 feet back) is dominated by trees with an abundant herbaceous/shrub layer. Floating, emergent aquatic plants and coarse woody habitat is present.

1. Maintain current protection of riparian zone.
2. No alteration of littoral zone.
3. Maintain fallen trees or coarse wood along the shoreline.
4. Maintain snag/perch trees.

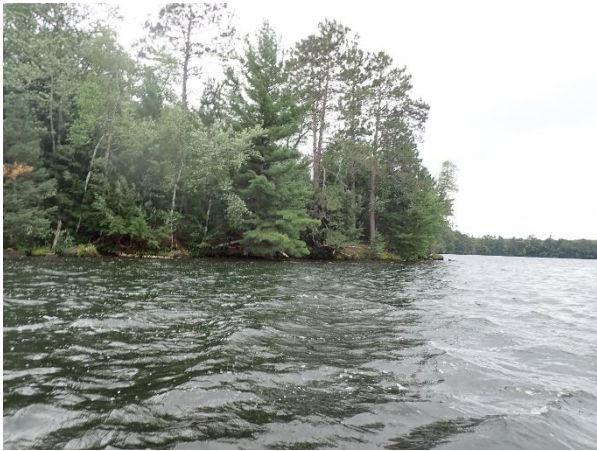
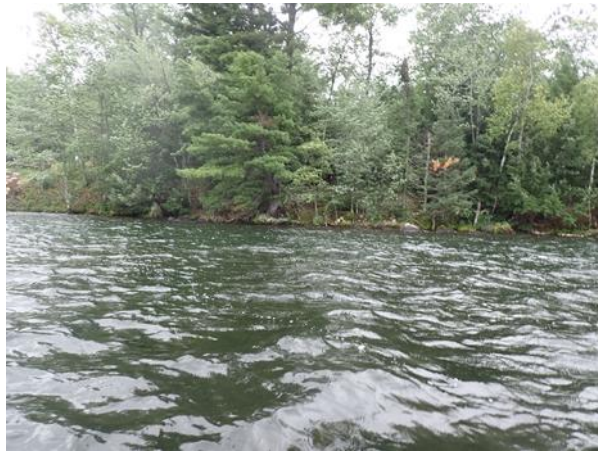
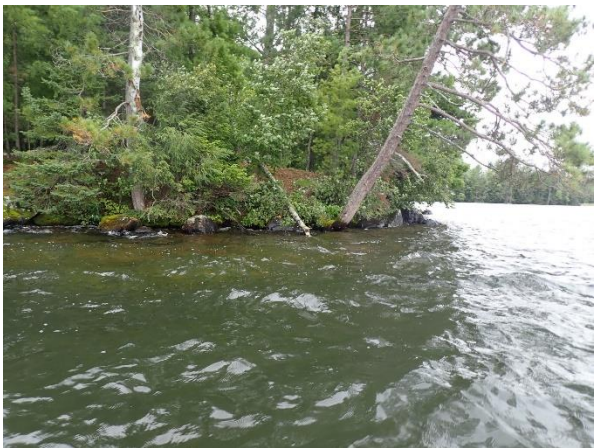
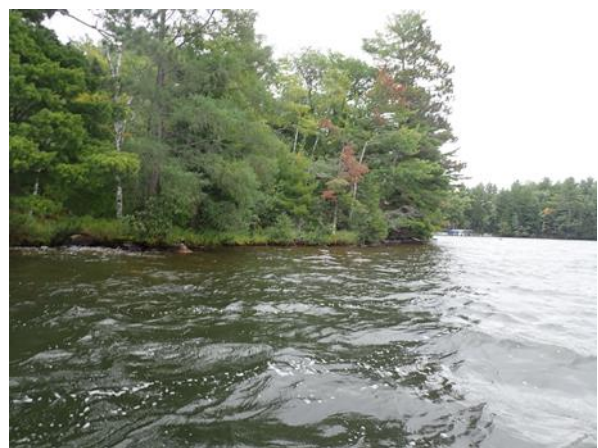
TL-12 Rock/Gravel Bar (west of Lark Road)

This is a rock/gravel bar with abundant coarse wood along an undeveloped shoreline. It was selected for its fish, wildlife value and natural scenic beauty (photos).

The site includes near-shore terrestrial, shoreline and littoral zone habitats. The riparian type (%) is 100% wooded. The buffer zone (from water's edge to 35 feet back) is dominated by trees with an abundant herbaceous/shrub layer. Floating and emergent aquatic plants are present. Coarse woody habitat is common.

1. Maintain current protection of riparian zone.
2. No alteration of littoral zone.
3. Maintain fallen trees or coarse wood along the shoreline.
4. Maintain snag/perch trees.

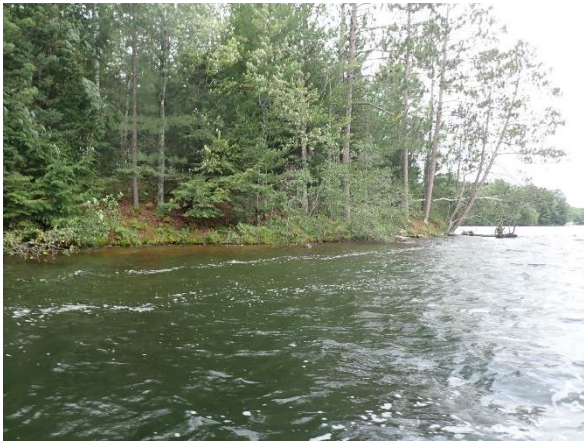
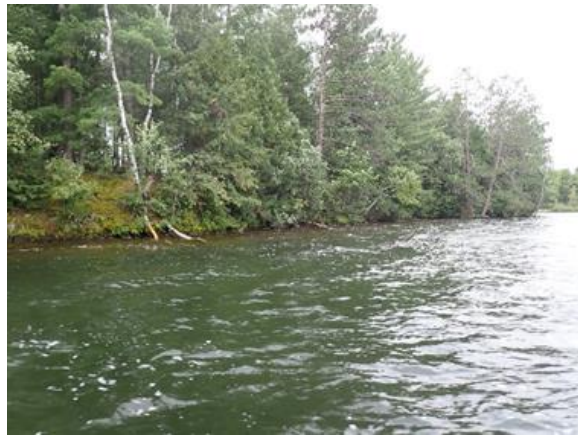
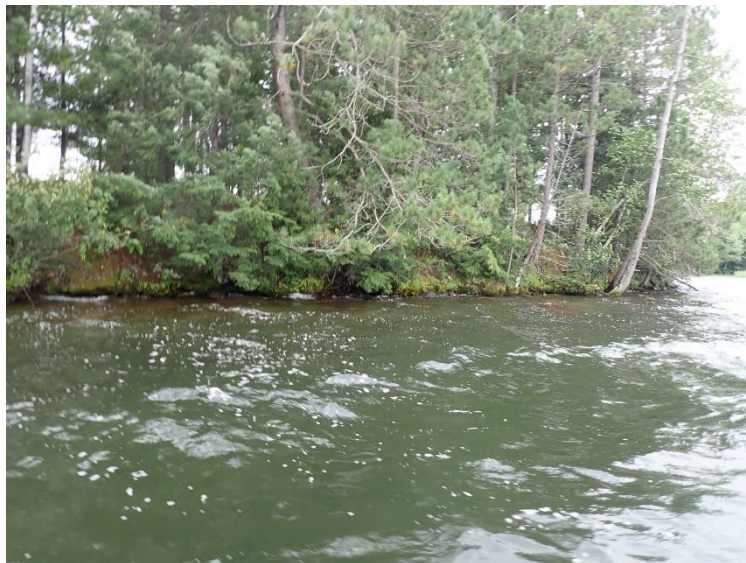
TL-13 Wetland Complex (north of Robin/Rainbow Road)

This is a large diverse wetland. It was selected for its fish and wildlife values, diverse aquatic vegetation and natural scenic beauty. There is minimal human disturbance (photos).

1. Maintain current protection.
2. No alteration of littoral zone.
3. Maintain fallen trees along the shoreline.

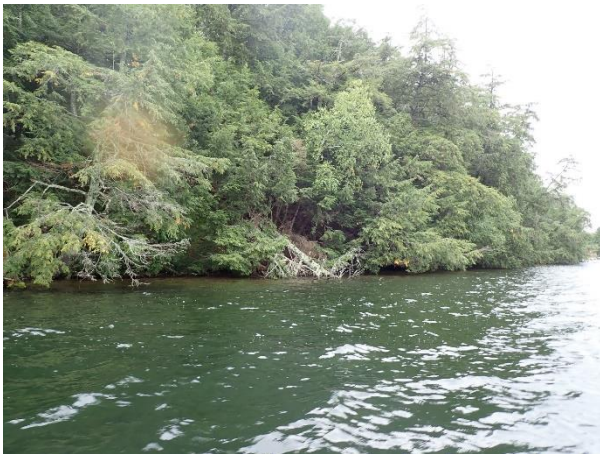
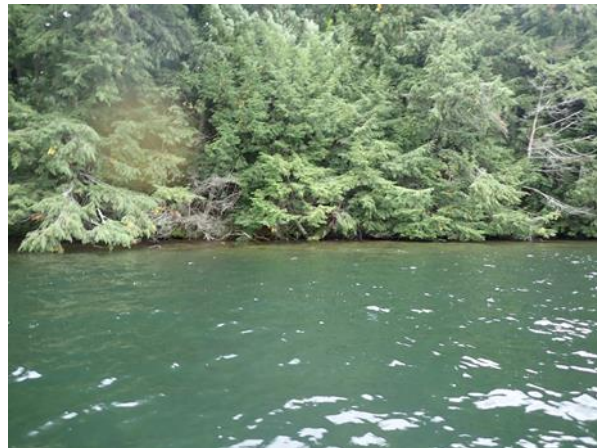
TL-16 Mud Lake Wetland Complex

This is a large diverse wetland which includes Mud Lake. It was selected for its fish and wildlife values, coarse wood, diverse aquatic vegetation and natural scenic beauty. There is no human disturbance (photos).

1. Maintain current protection.
2. No alteration of littoral zone.
3. Maintain snag and cavity trees for cavity nesting species.
4. Maintain fallen trees along the shoreline.

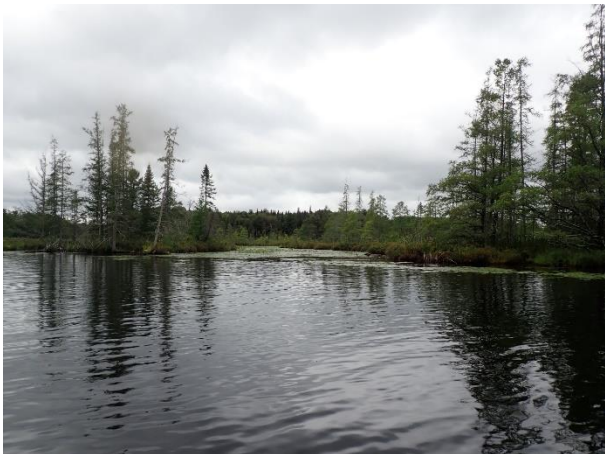
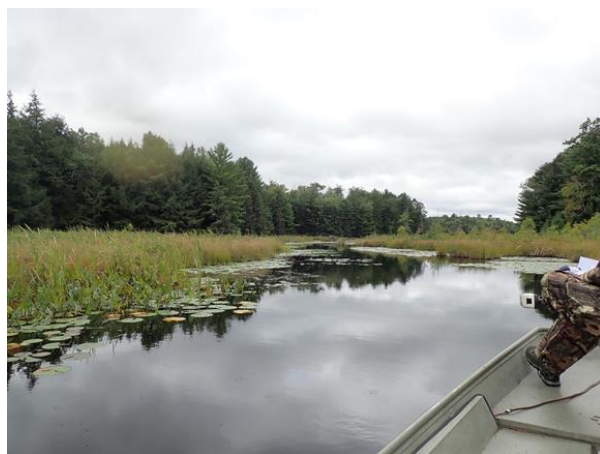
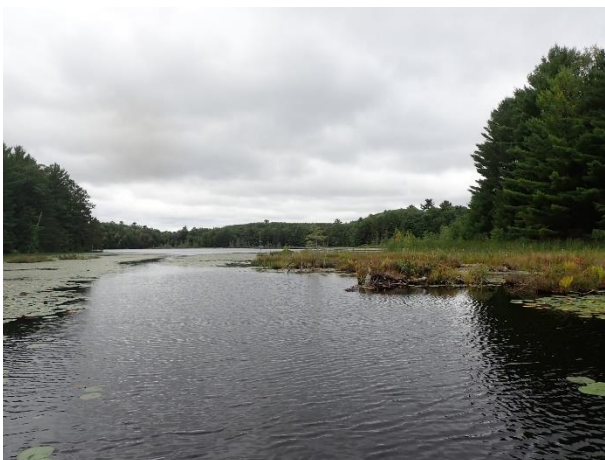
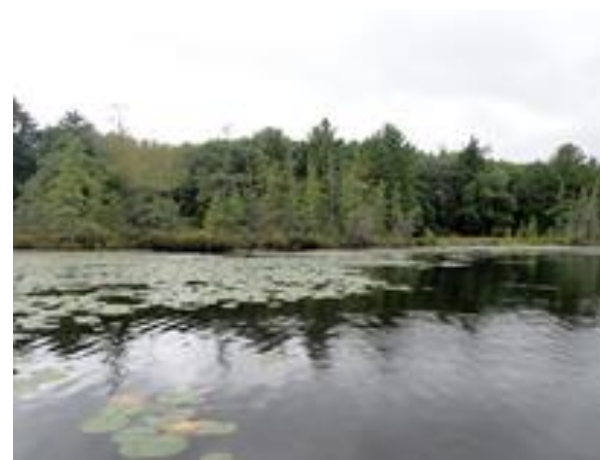
TL-17 Romans Point

This is an extensive (2 miles) undeveloped shoreline which provides a variety of habitat types. It was selected for its fish and wildlife values, diverse aquatic vegetation, coarse wood, rock& rubble substrate and natural scenic beauty. There is minimal human disturbance (photos).

The site includes nearshore terrestrial, shoreline and littoral zone habitats. The riparian type (%) is 100% wooded. The buffer zone (from water's edge to 35 feet back) is dominated by trees with herbaceous/scrubs abundant. Coarse woody cover is common. There is also extensive rock rubble fish habitat.

1. Maintain current protection.
2. No alteration of littoral zone.
3. Maintain fallen trees along the shoreline.
4. Maintain snag/perch trees.

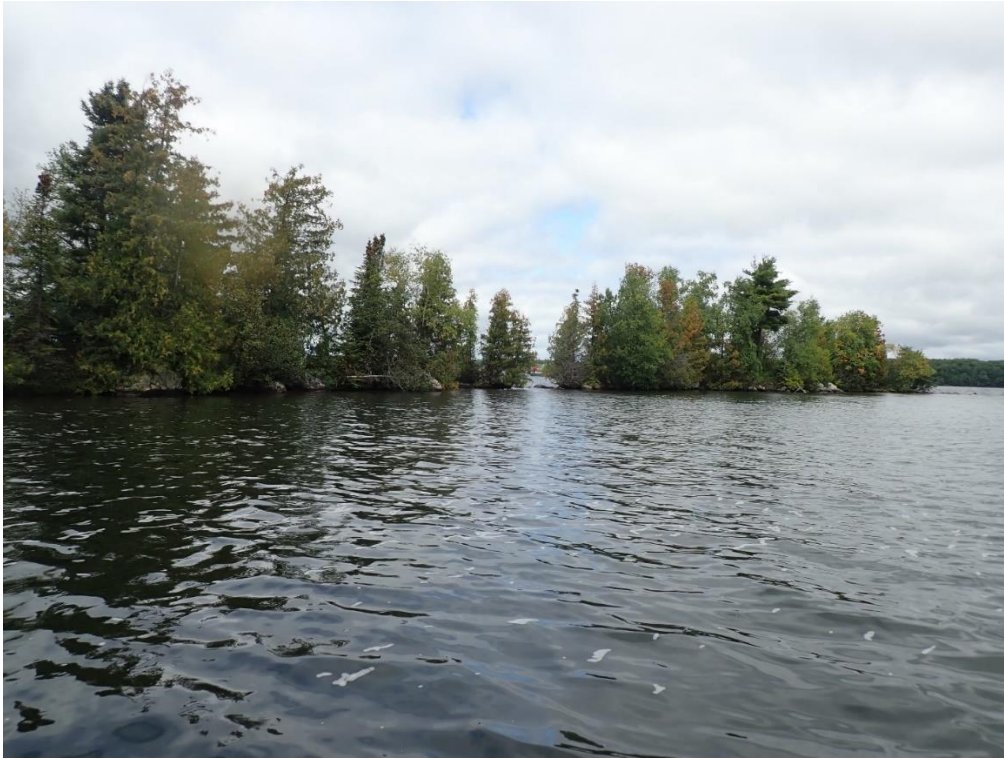
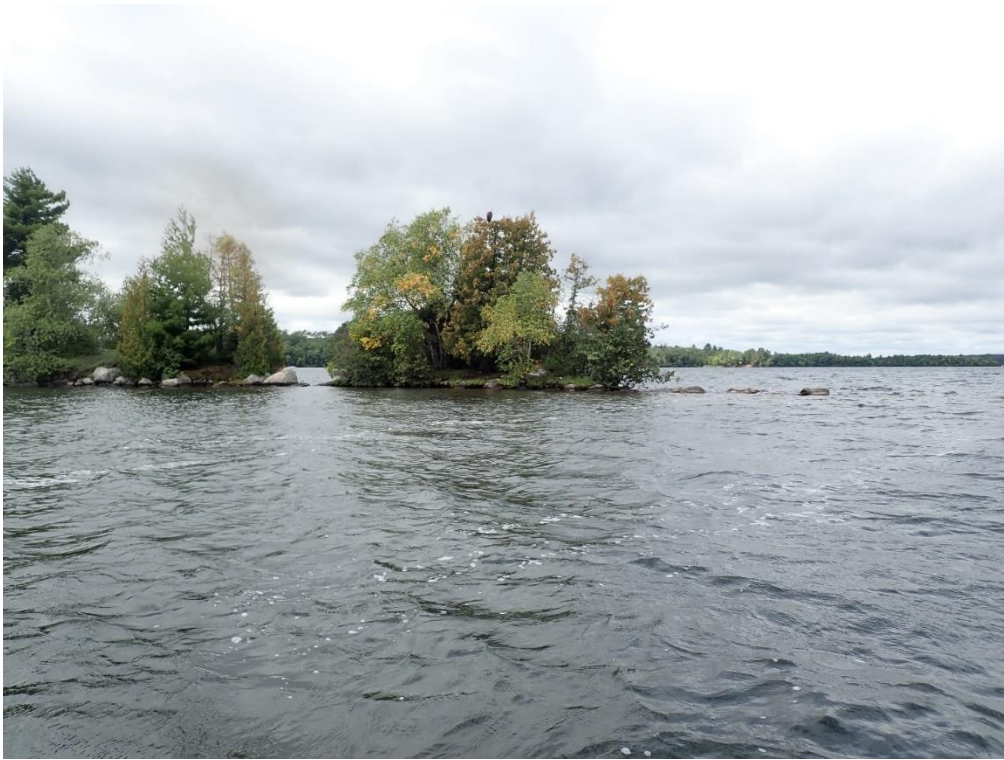
This is a rock/gravel bar that surrounds most of the Island. It was selected primarily for its fishery value but there are some wildlife benefits as well (photos).

1. Maintain current protection of riparian zone.
2. No alteration of littoral zone.
3. Do not remove fallen trees from shoreline.

4. Maintain snag/cavity trees.
5. Lots of human use of island. One third of island is de-vegetated. These areas use should be replanted and recreational use of the site better managed – perhaps through fencing.

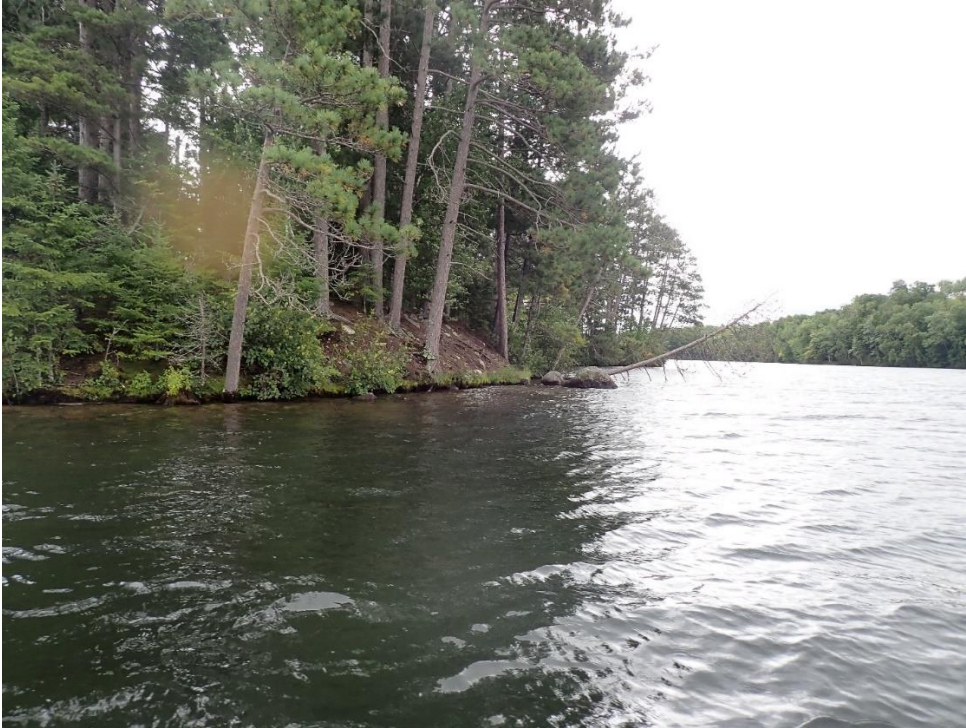
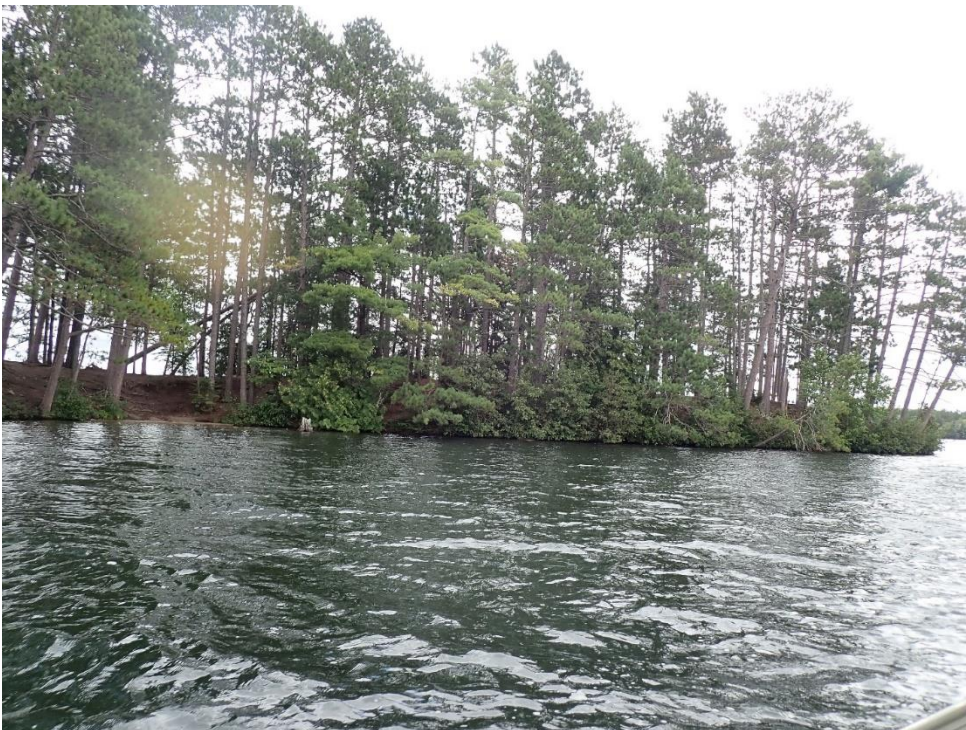
A rock/gravel bar surrounds two thirds of the island. It was selected primarily for its fishery and wildlife value.

1. Maintain current protection of riparian zone.
2. No alteration of littoral zone.
3. Do not remove fallen trees from shoreline.
4. Maintain snag/cavity trees.
5. Some de-vegetated areas on the north and south tip of island from human use should be replanted and recreational use of the site better managed.

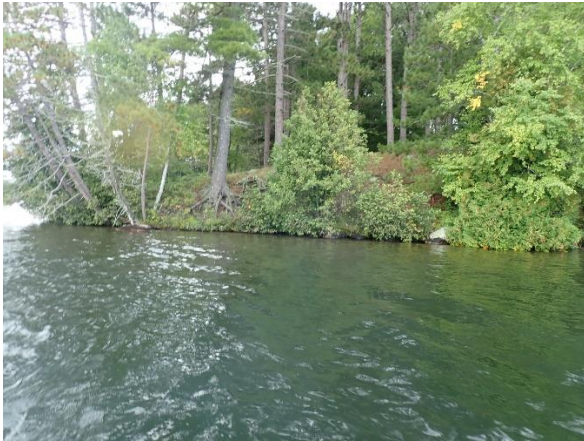
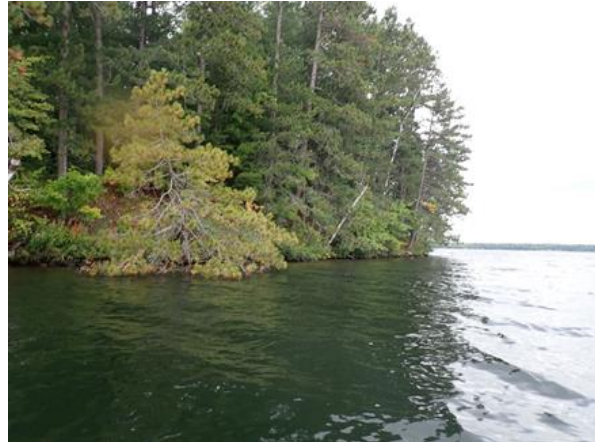
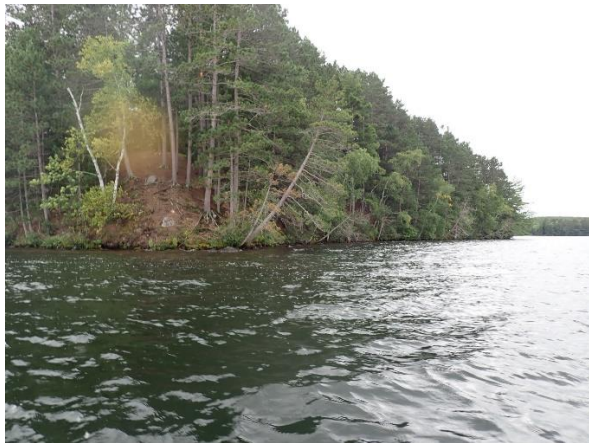
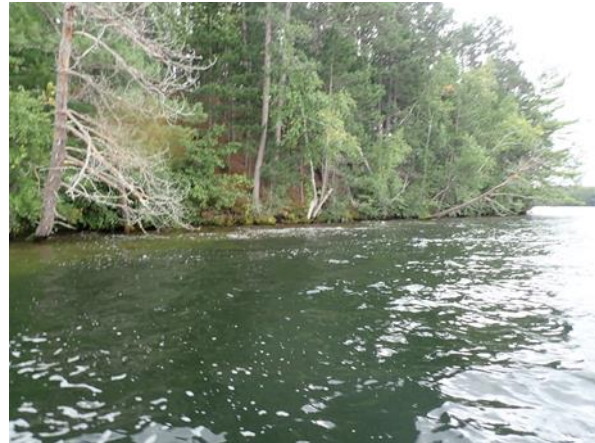
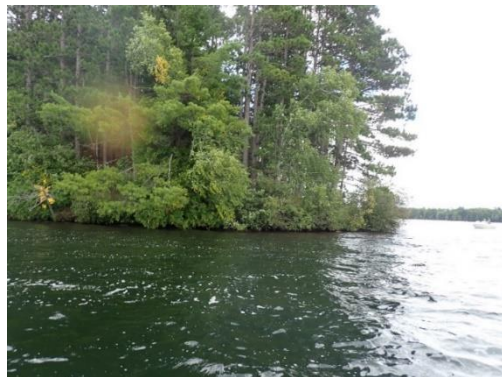
TL-21 Eagle Bay Rock Bar (west of Picnic Island)

This is a rock/gravel bar. It was selected primarily for its fishery value (photos).

1. Maintain current protection of riparian zone.
2. No alteration of littoral zone.
3. Add fallen trees or coarse wood along the shoreline.

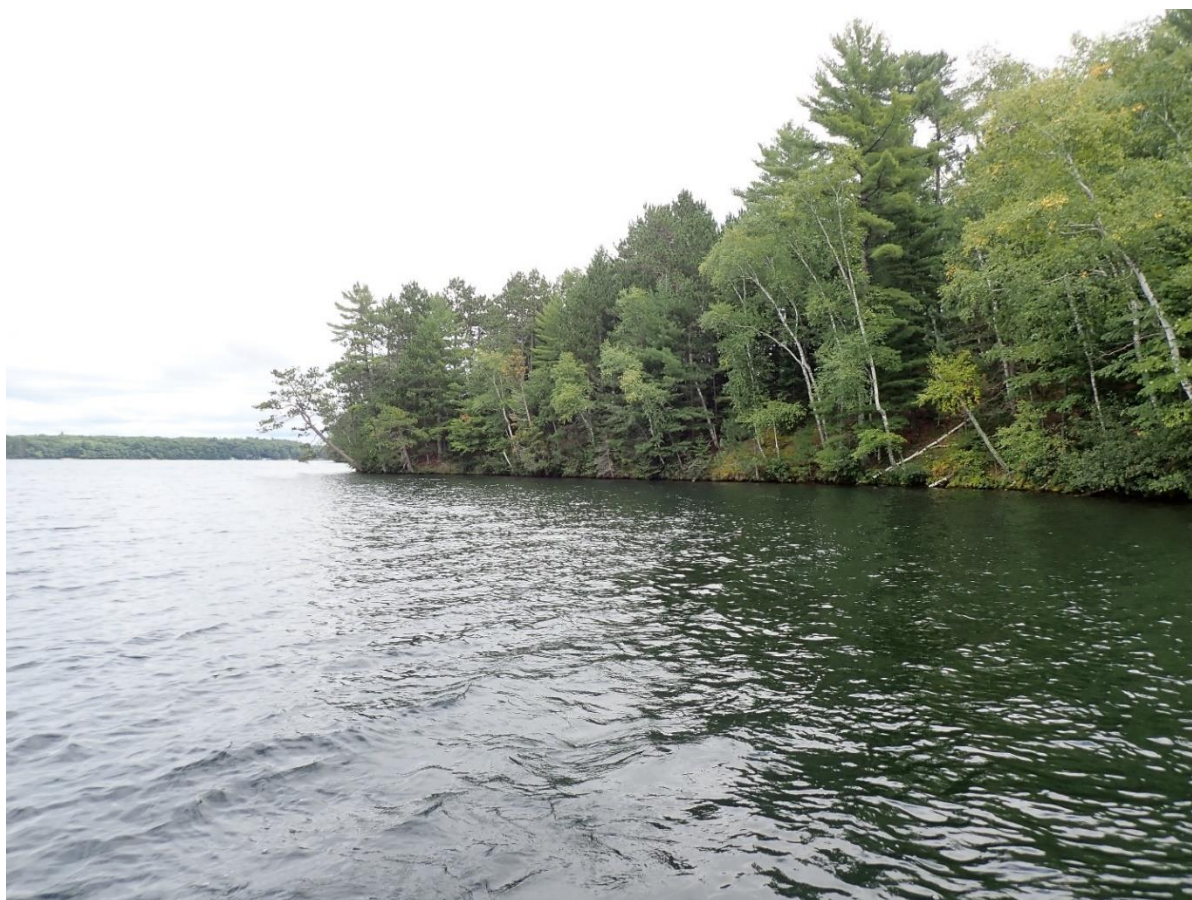
TL-22 Eagle Bay

This is a large undeveloped bay. It was selected for its fish and wildlife values, diverse aquatic vegetation, large wetlands and natural scenic beauty. There is minimal human disturbance (photos).

1. Maintain current protection.
2. No alteration of littoral zone.
3. Maintain snag and cavity trees for cavity nesting species.
4. Maintain fallen trees along the shoreline.

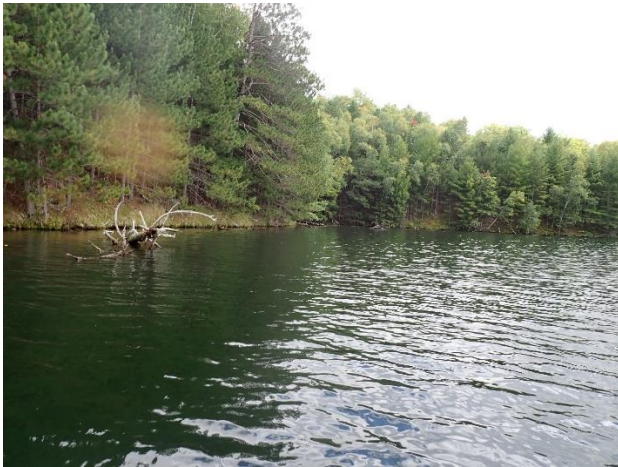
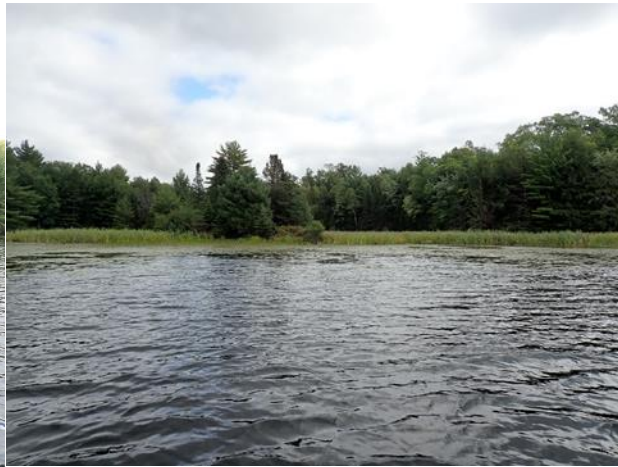
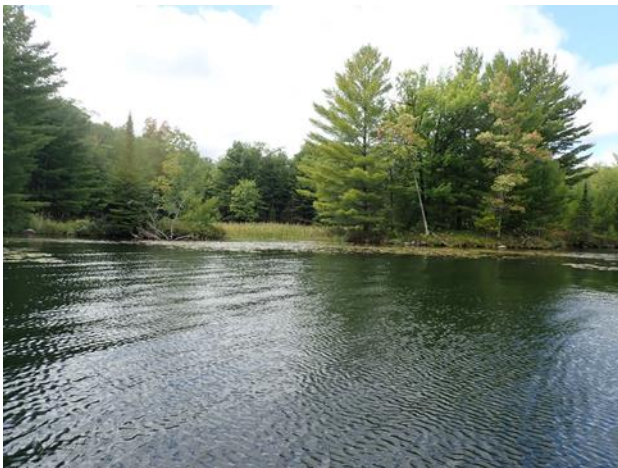
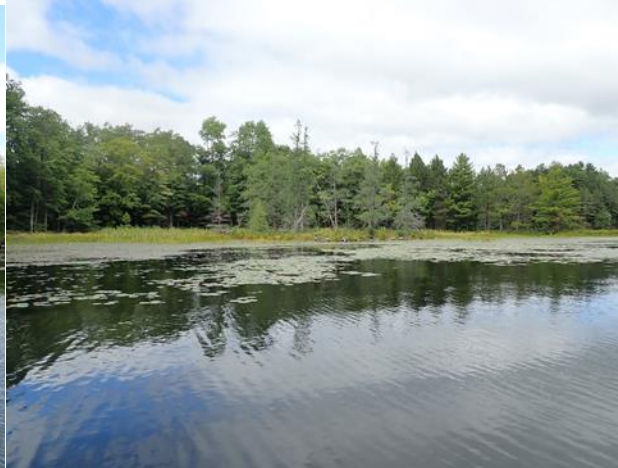
TL-23 Shoreline from Eagle Bay north to Windy Point

This is an extensive (> 2 miles) undeveloped shoreline in public ownership. It was selected for its fish and wildlife values, diverse aquatic vegetation, coarse wood, rock rubble substrate and natural scenic beauty. There is minimal human disturbance (photos).

1. Maintain current protection.
2. No alteration of littoral zone.
3. Maintain fallen trees along the shoreline.
4. Maintain snag/perch trees.

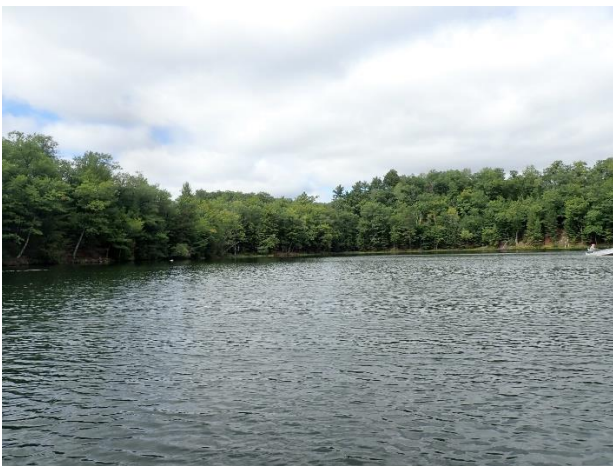
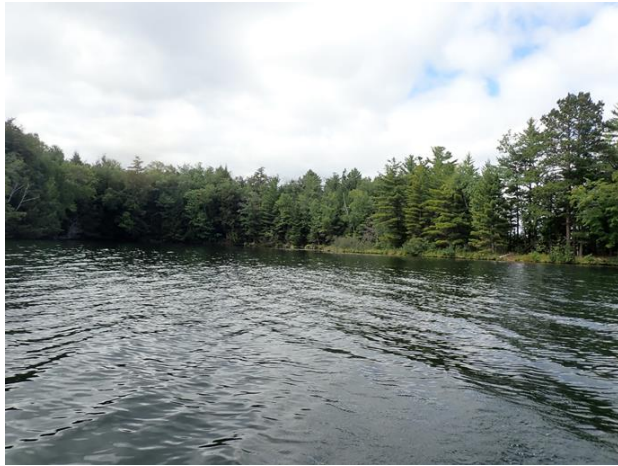
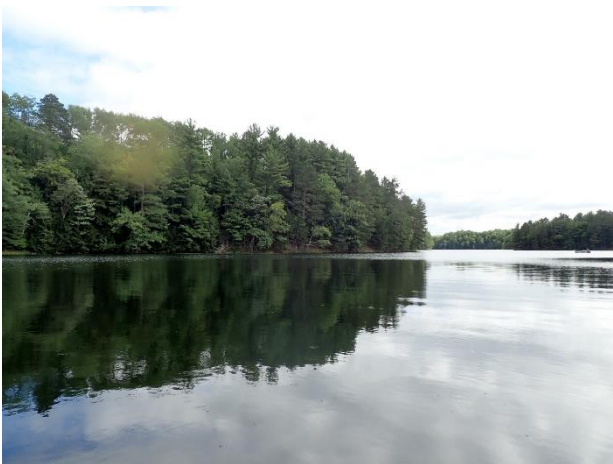
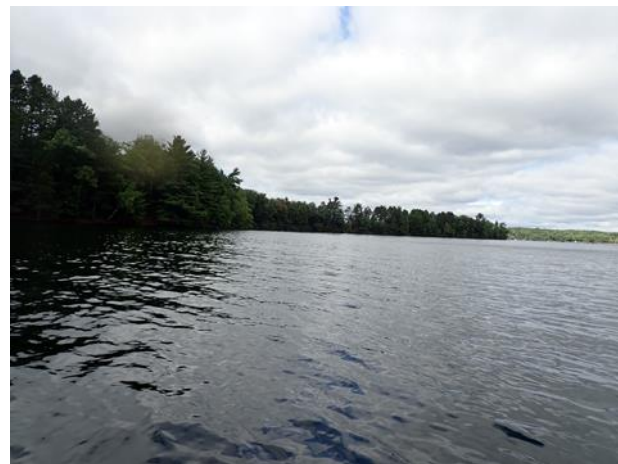
TL-24 Windy Point

This location, often referred to the “otter slide”, had the most severe erosion and run-off problems observed on Tomahawk Lake. Human use of the adjacent steep sandy upland has resulted in over 200’ of gullying and channeling of run-off with >250’ of bank erosion present. Because of the high concentration of use and steep slopes, management of the site could include fencing and signage and perhaps seasonal porta-potty facilities to keep people off the steep upland sites. Again, this location is within Critical Habitat site TL-24 – see Critical Habitat Report for more information.

This point has an extensive offshore rock bar. It was selected primarily for its scenic beauty, fishery value but there are some wildlife benefits as well (photos).

1. Maintain current protection of riparian zone.
2. No alteration of littoral zone.
3. Maintain snag/cavity trees.
4. Do not remove coarse woody cover along shoreline.

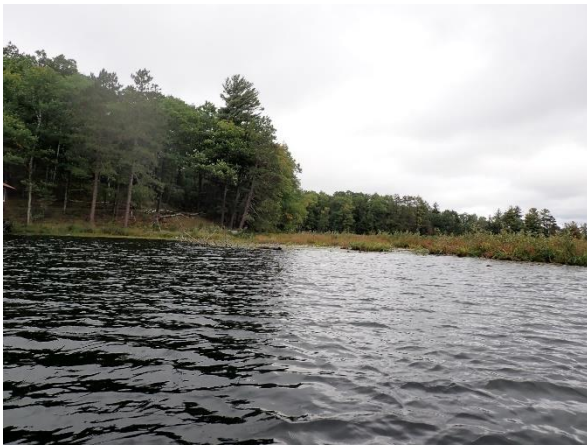
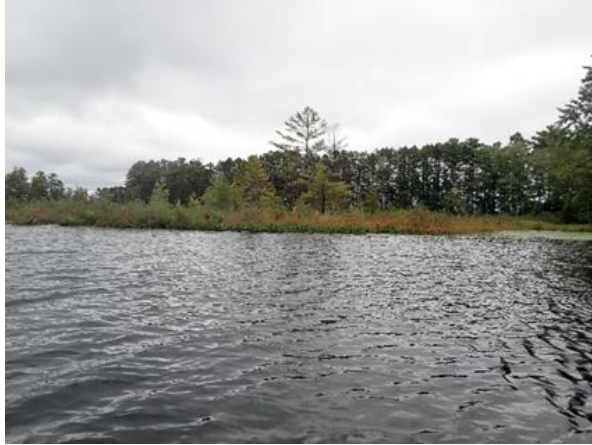
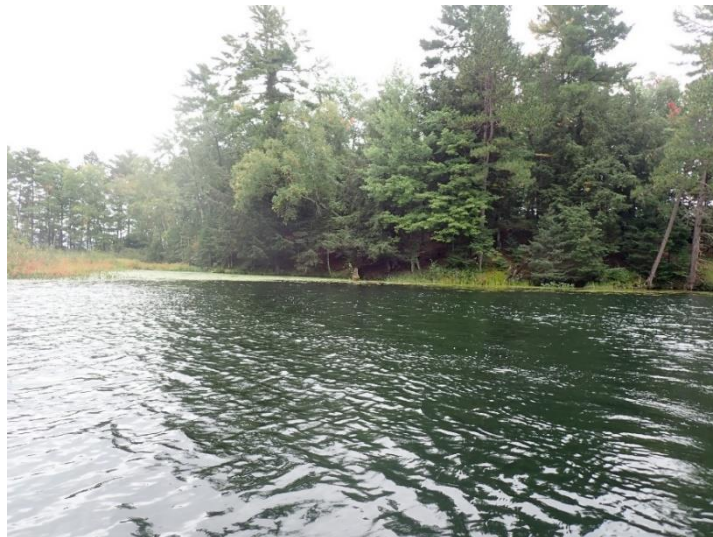
TL-31 Rock/Gravel Bar (southwest of Clearwater Camp)

This is a rock/gravel bar. It was selected for its fishery value (photos).

The site includes near-shore terrestrial, shoreline and littoral zone habitats. The riparian type (%) is 100% wooded. The buffer zone (from water's edge to 35 feet back) is dominated by trees with an abundant herbaceous/shrub layer. Coarse woody cover is present.

1. Maintain current protection of riparian zone.
2. No alteration of littoral zone.

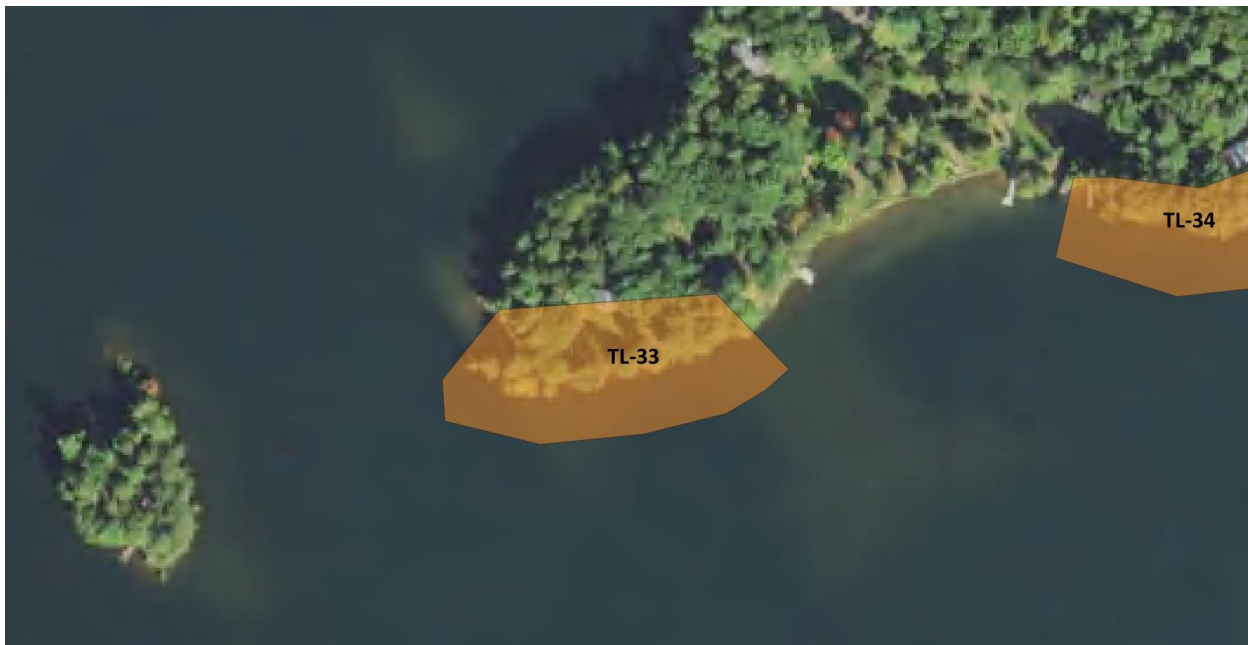
The site includes near-shore terrestrial, shoreline and littoral zone habitats. The riparian type (%) is 70% wooded and 30% developed. The buffer zone (from water's edge to 35 feet back) is dominated by trees with an abundant herbaceous/shrub layer.

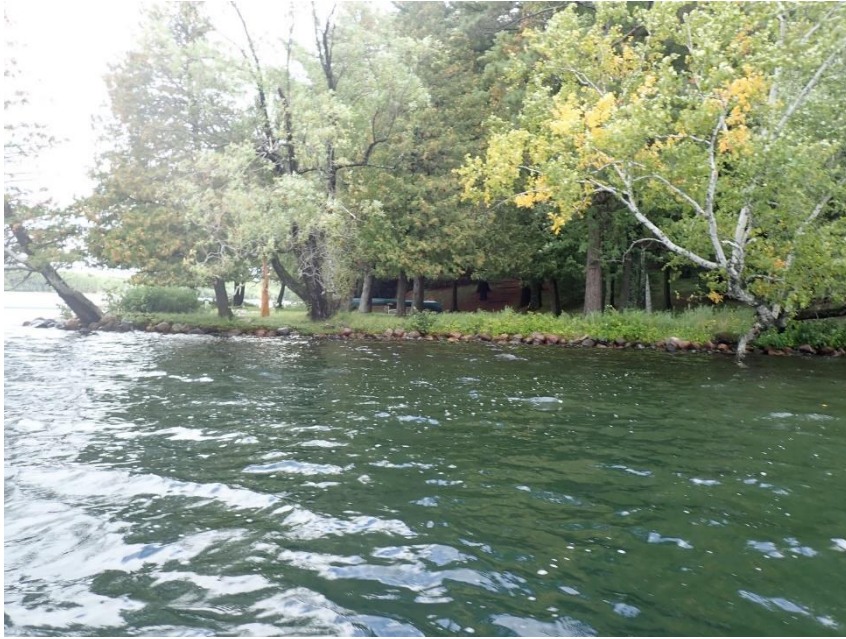
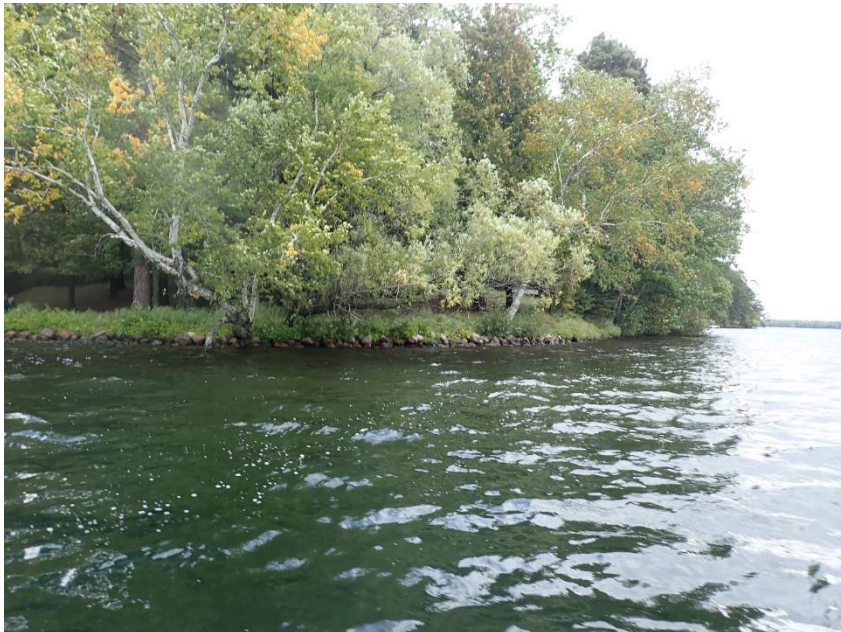
TL-34 Rock/Gravel Bar Olmsteads Island (east side of island)

This is a rock/gravel bar with abundant coarse woody cover. It was selected primarily for its fishery value but there are some wildlife benefits as well (photos).

The site includes near-shore terrestrial, shoreline and littoral zone habitats. The riparian type (%) is 70% wooded and 30% developed. The buffer zone (from water's edge to 35 feet back) is dominated by trees with an abundant herbaceous/shrub layer. There is abundant coarse wood and overhanging vegetation.

1. Maintain current protection of riparian zone.
2. No alteration of littoral zone.
3. Do not remove fallen trees from shoreline.
4. Maintain snag/cavity trees.

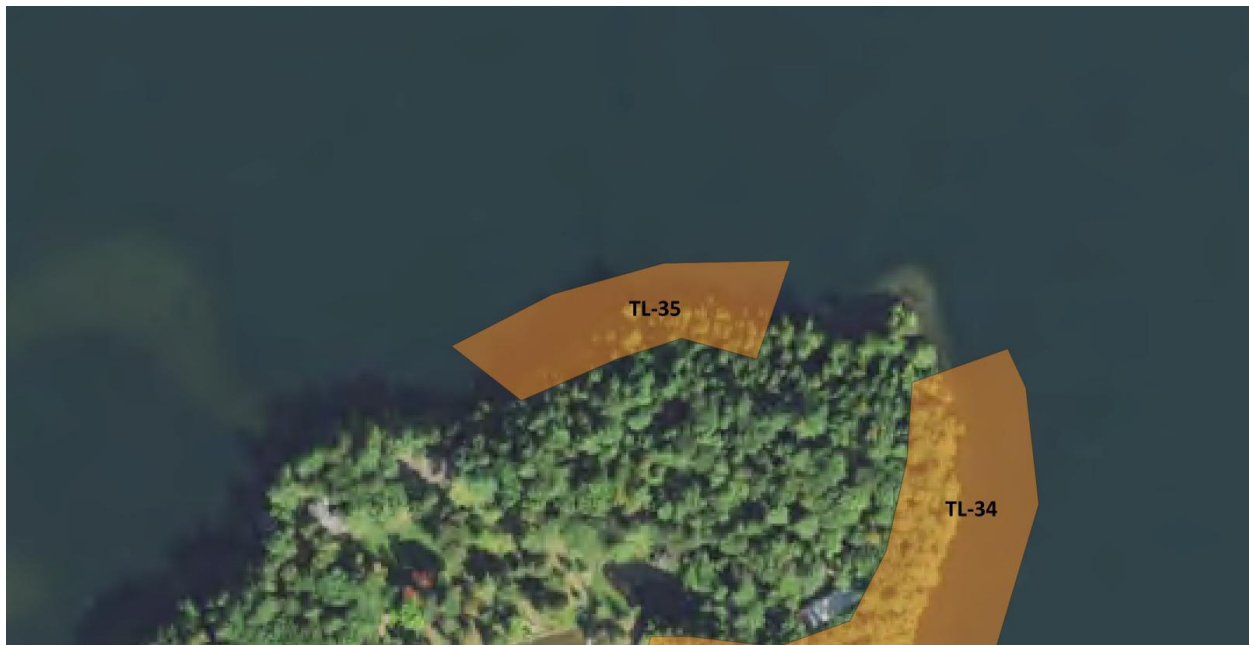
The site includes near-shore terrestrial, shoreline and littoral zone habitats. The riparian type (%) is 70% wooded and 30% developed. The buffer zone (from water's edge to 35 feet back) is dominated by trees with an abundant herbaceous/shrub layer. There is abundant coarse wood and overhanging vegetation.
