TOMAHAWK LAKE ASSOCIATION'S STORMWATER AND SHORELAND GIS PROJECT – AN OVERVIEW

Mike Meyer and Jim Kreitlow

August 1, 2020

ASSESSING THE STATE OF TOMAHAWK LAKE'S SHORELANDS - 2020

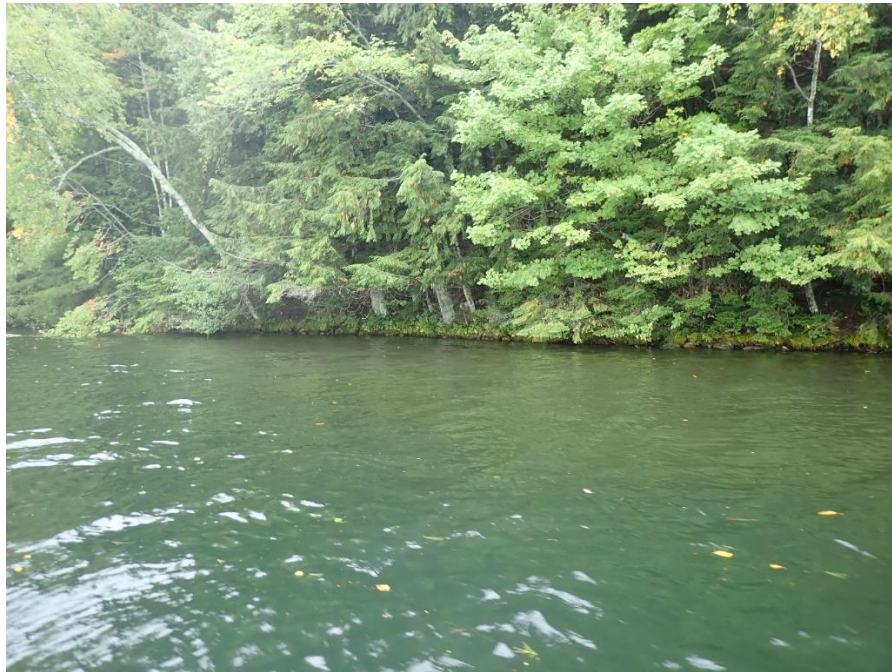
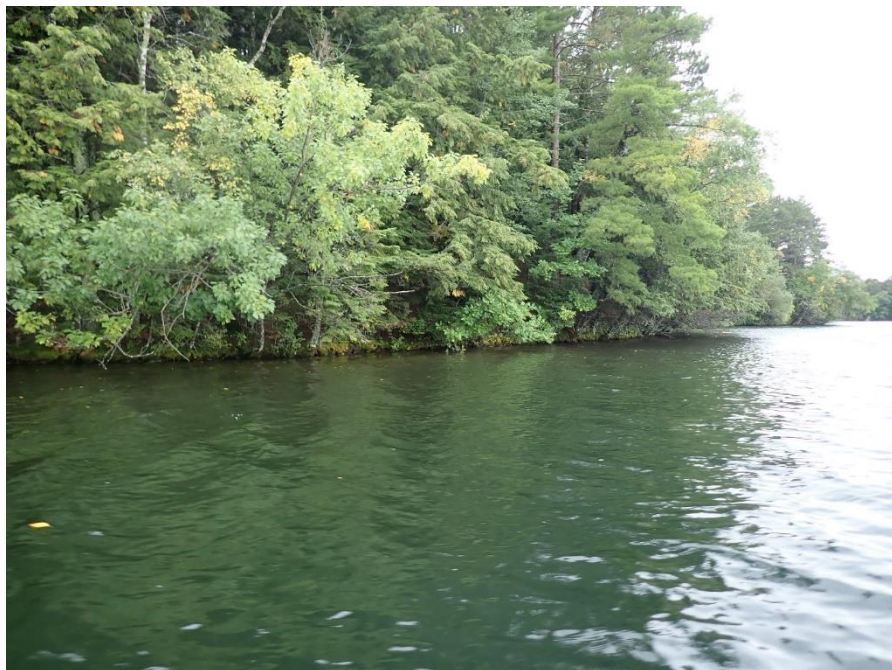
TL-36 Rock Bar west of Ohmsteads Island (tip of Camp Minocqua Road)

This is a rock/gravel bar. It was selected for its fishery value (photos).

The site includes shoreline and littoral zone habitats. The riparian type (%) is 60% wooded and 40% developed. The buffer zone (from water's edge to 35 feet back) has abundant trees and herbaceous/scrubs. Coarse woody cover is present.

2. Maintain current protection.
3. No alteration of littoral zone.
4. Add fallen trees or coarse wood along the shoreline.

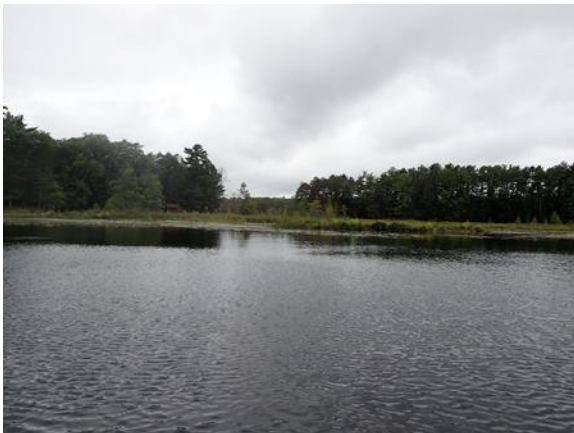
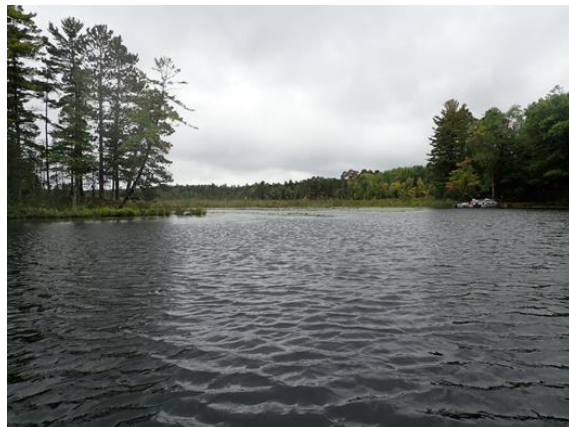
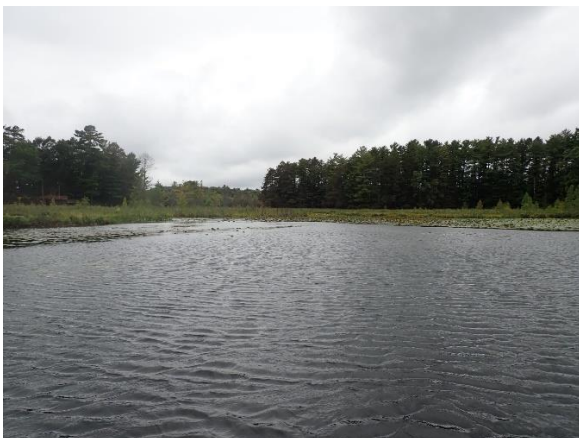
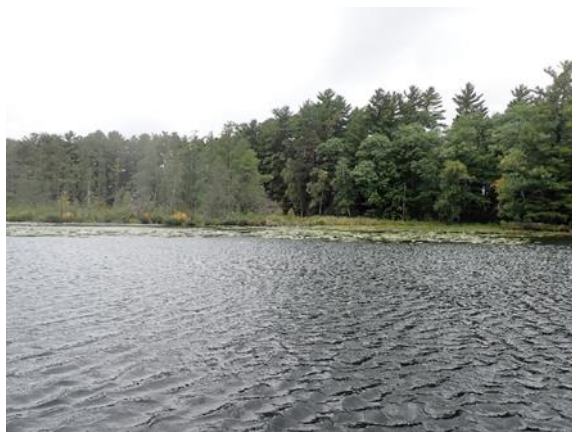
TL-38 Rock Bar Point north of Musky Bay

This is a rock/gravel bar. It was selected for its fishery value (photos).

The site includes shoreline and littoral zone habitats. The riparian type (%) is 100% wooded. The buffer zone (from water's edge to 35 feet back) is dominated by trees and abundant herbaceous/shrubs.

1. Maintain current protection.
2. No alteration of littoral zone.
3. Add fallen trees or coarse wood along the shoreline.

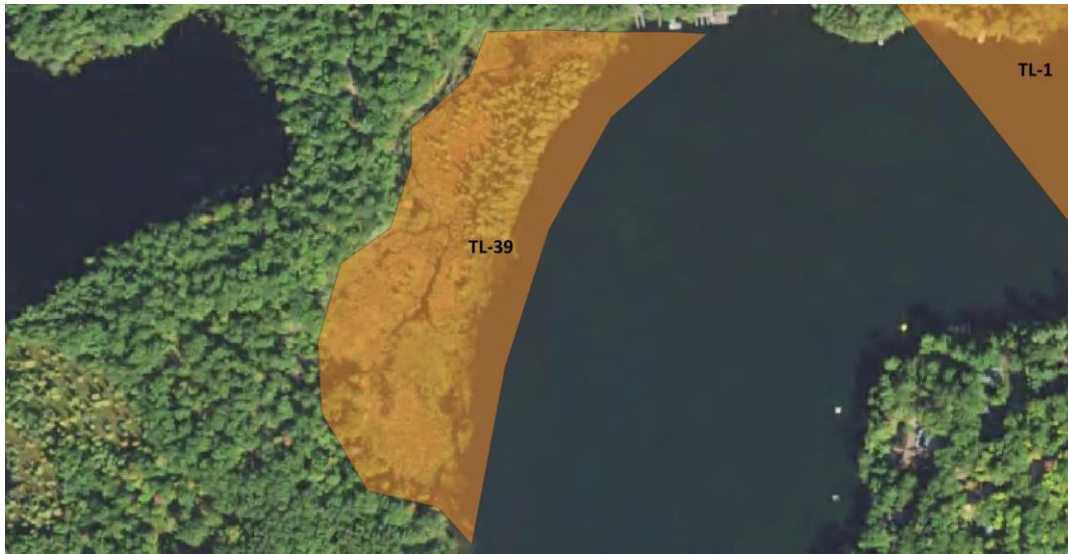
The site includes nearshore terrestrial, shoreline and littoral zone habitats. The riparian type (%) is 70% wetland and 30% wooded. The buffer zone (from water's edge to 35 feet back) is dominated by herbaceous/scrubs and trees. Coarse woody cover is present.
